**FULL BUILDING SURVEY**

**Lynbrook House  
Stocks Lane  
Bristol  
BS14 7DG**

**10 October 2016**

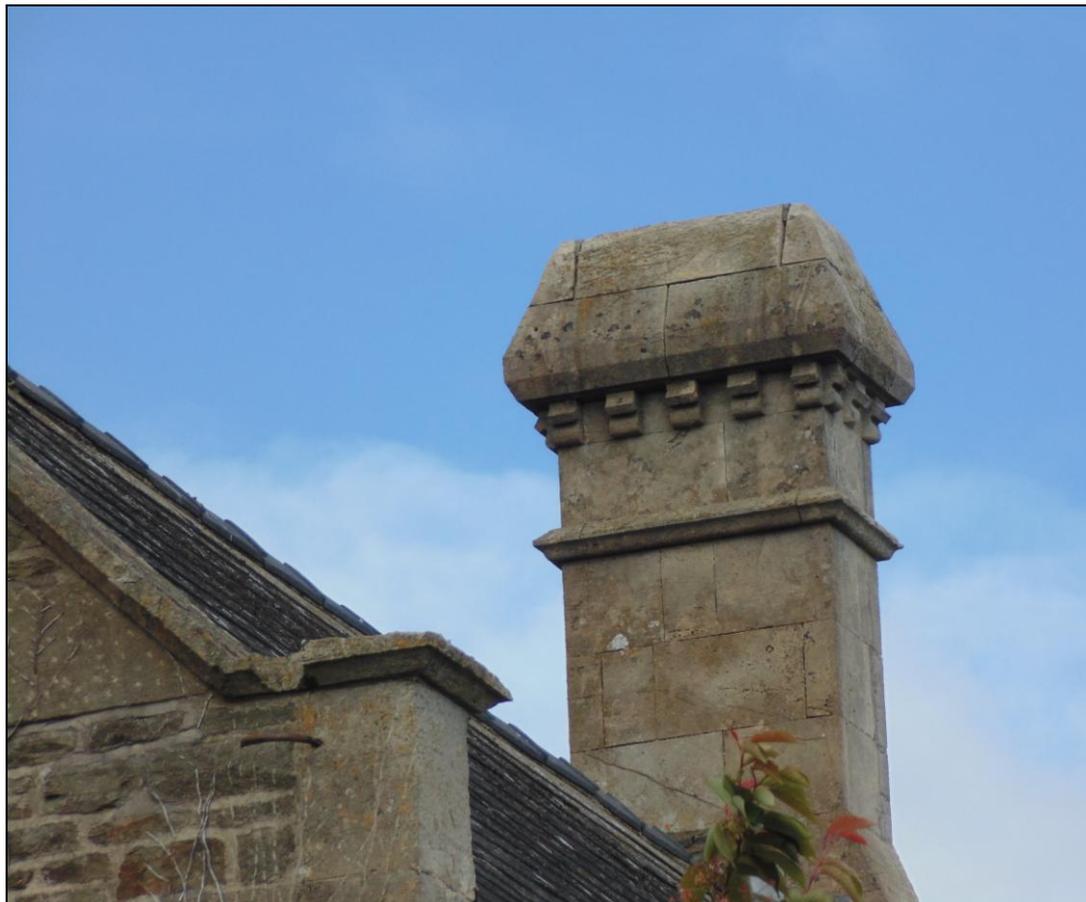
### Left hand rear stack

At the time of the survey we did note evidence of slight inward lean, particularly in terms of the rear left hand stack although elevations of other structures appeared to be satisfactory. Distortion on the inwardly leaning stack, which is located on the large left hand gable of the original structure, was considered to be within acceptable limits.

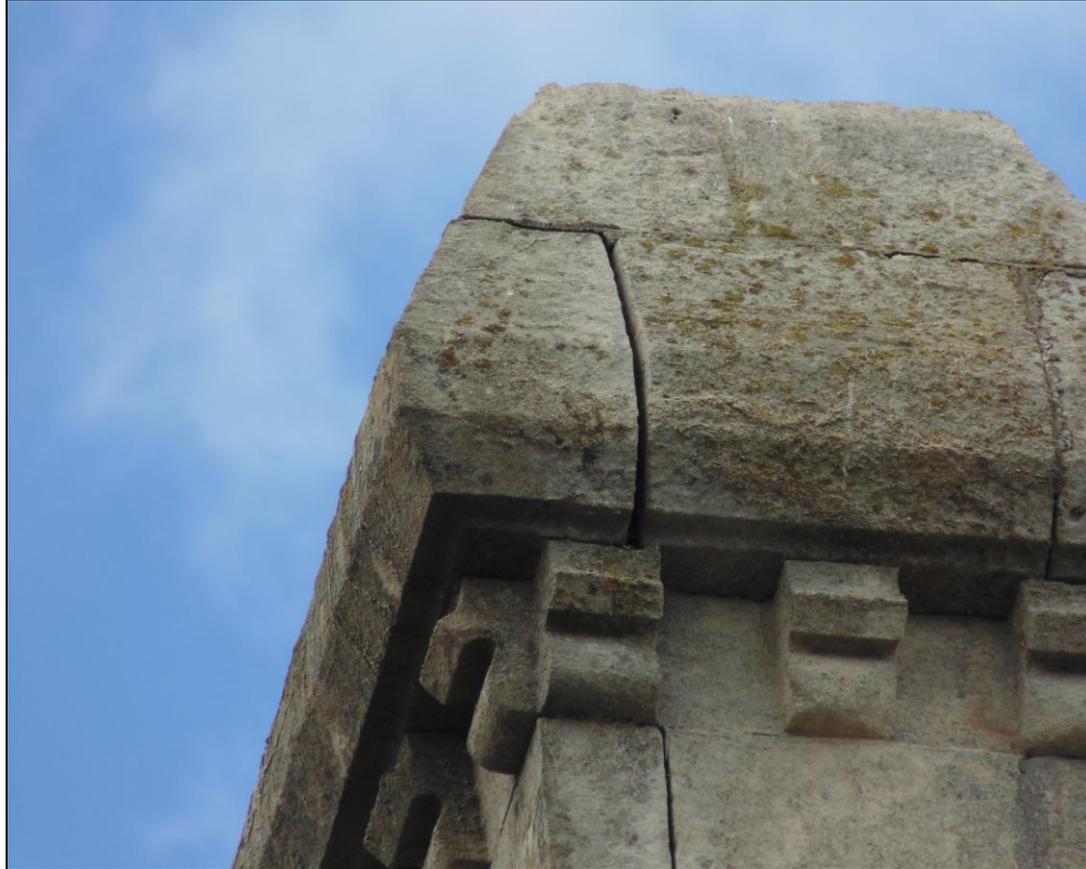
Stonework itself was in reasonable condition for a building of this age and type although there are, inevitably, a number of open joints to sections of the stonework which can be seen in adjacent photographs. This is certainly not unexpected or particularly excessive although is likely to deteriorate further with age without repairs. Raking out and repointing should be considered as part of refurbishment works.

**Open pointing on rear left hand stack**

**Action: Ensure continued maintenance of chimney stacks, particularly in relation to repointing and also refixing of flashings/soakers where appropriate.**

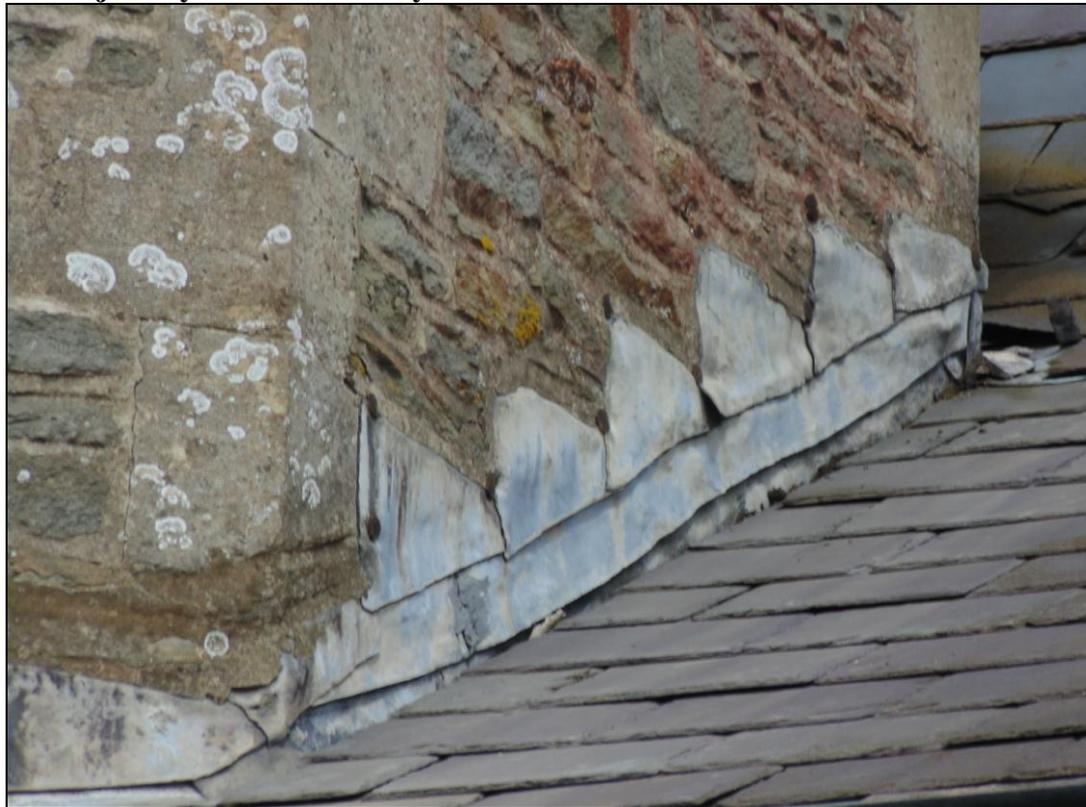
**Lifted joinery on rear chimney stack**

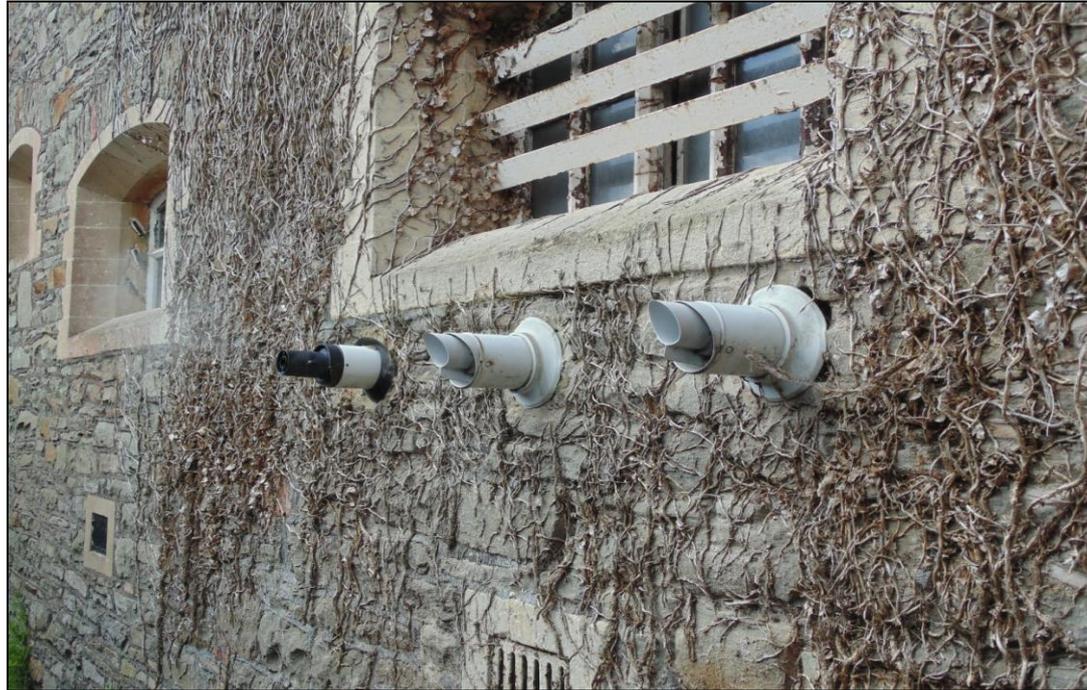
Boiler flues are located on the rear of the original structure and appeared to be suitably positioned. Functional tests should be arranged on the boilers through a GAS SAFE heating engineer in the absence of any recent test certificates.

### **Boiler flues on rear elevation**

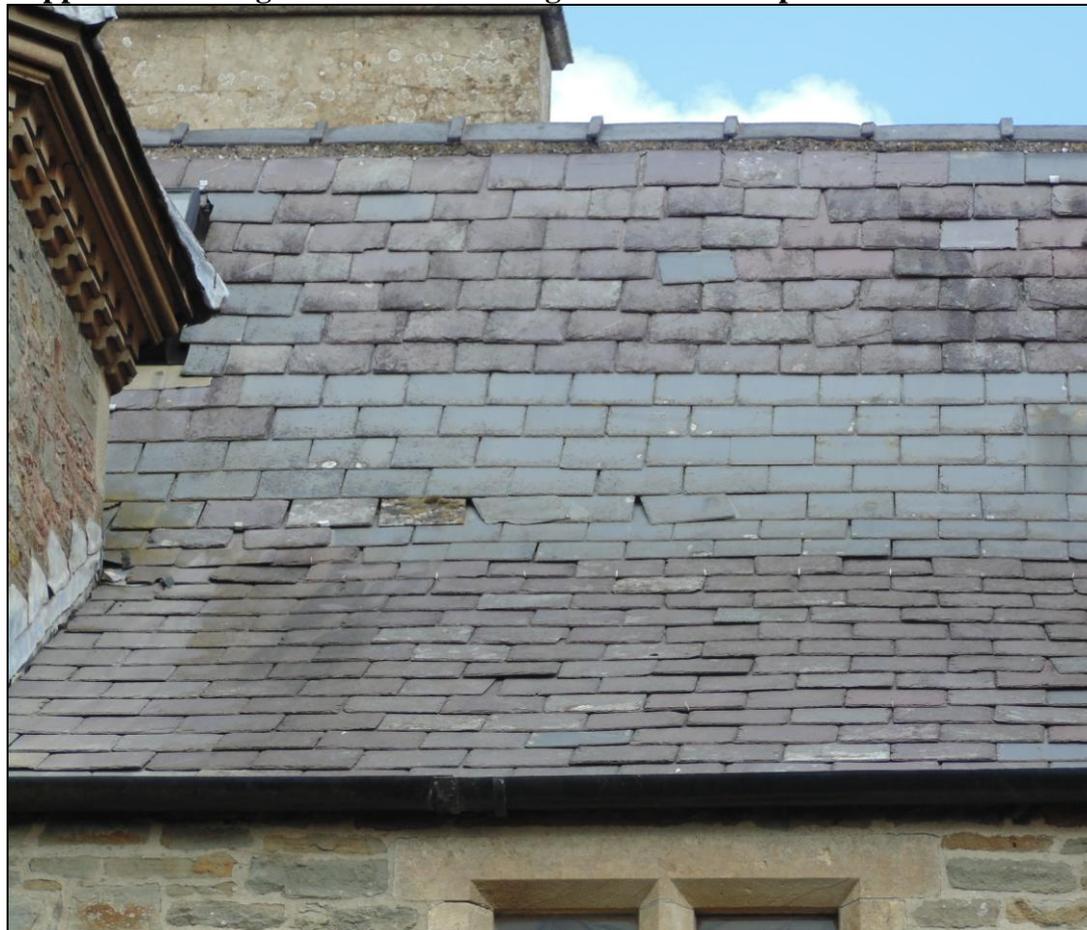
Inspection from ground level and, indeed, in the inner valley areas revealed a number of slipped and damaged slates and it is clear that replacement sections are now required. Others have been refixed with lead tingles suggesting that slipping has been a problem in the past. Whilst complete recovering is not necessary, there will certainly be a fair amount of refixing in relation to slates and also replacement of any damaged sections. We also noted deterioration to ridge bedding which will potentially allow water penetration and lifting and rebedding of ridge tiles is recommended.

#### **Slipped and damaged slates noted on right hand roof slope**

**Action: Instruct a suitably competent roofing contractor (preferably one experienced with older buildings) to carry out an inspection of the roof and provide estimates for general overhaul. This may be potentially expensive and we recommend that this be undertaken prior to exchange of contracts.**

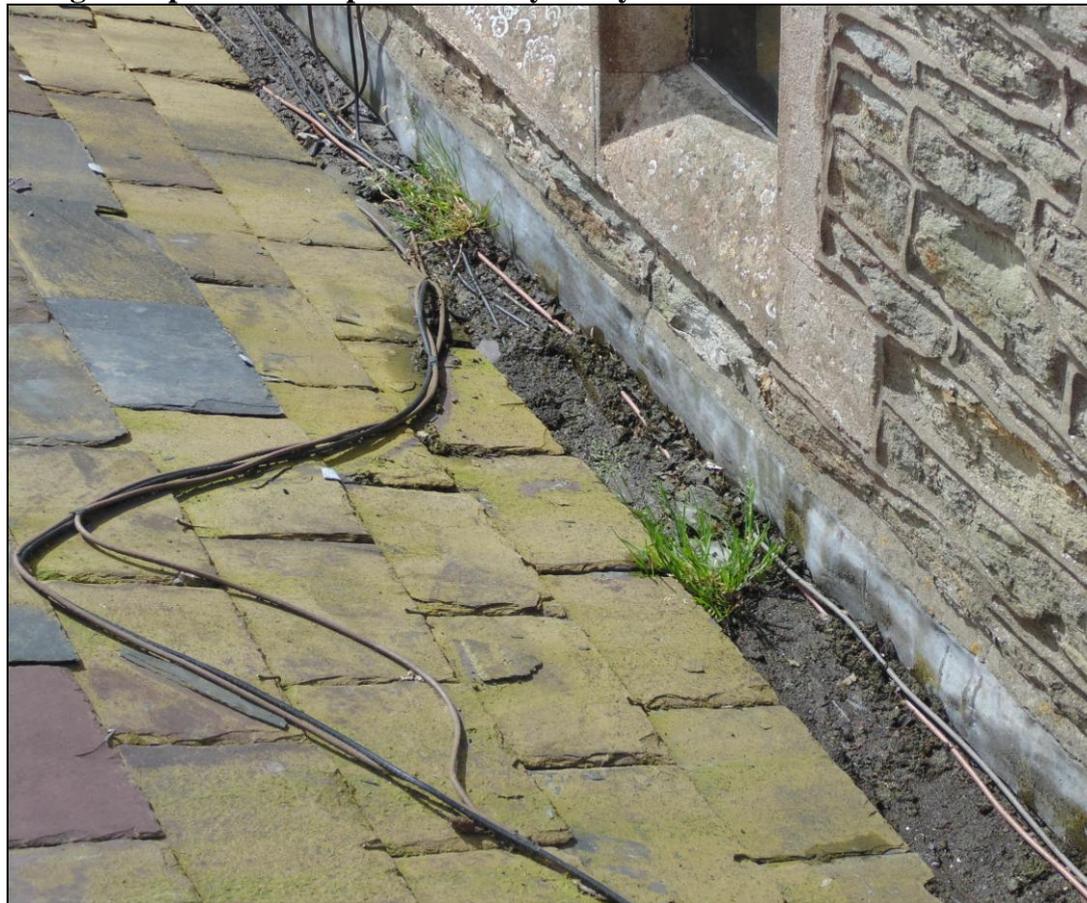
There is a central valley area on the main roof which leads to a secondary valley taking water to the right hand side of the building. Coverings comprise lead work which is typical of a building of this age and design. The main central valley was in satisfactory condition and no obvious leaking was noted below. The secondary valley did show evidence of some sludge build up and this clearly requires clearing out. This may have occurred due to a fairly shallow gradient and it will not be easy to redesign should you wish to do so. This will naturally require the regular inspection of valleys and cleaning out of debris to allow water to channel to ground level appropriately. There are also a number of sloping valleys at the intersection of roof slopes, again, lined with lead work. Sloping and horizontal valleys are notoriously prone to blockage and deterioration and can be a frequent source of water penetration internally. Whilst we found no indication of leaking, regular checks on lining materials will be required with any blockage removed as soon as possible.

#### **Sludge and plant build up in secondary valley**

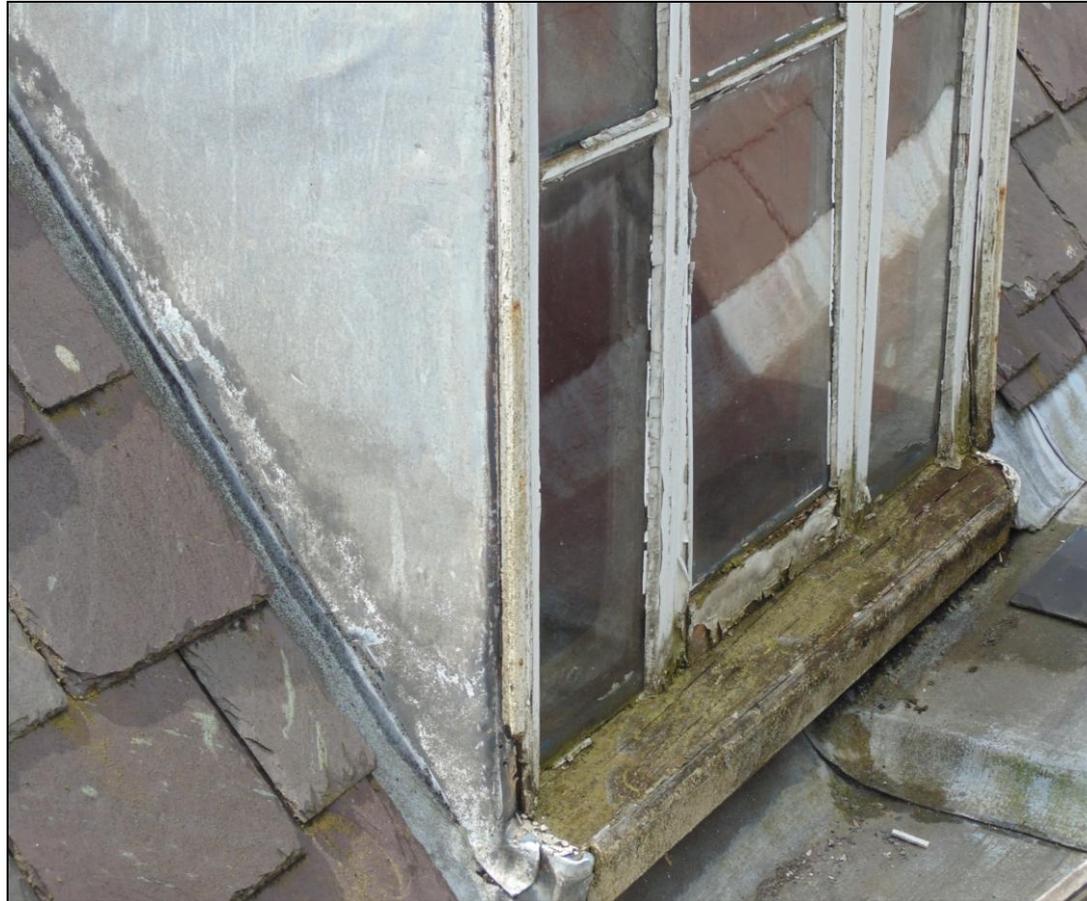
Dormer sections have been incorporated on the inner roof slopes. Rot was noted to many areas and cutting out and replacement of defective timbers is a requirement. Lead covered roofs are present on the dormers which showed no indication of leaking at the time of our survey.

#### **Rot noted to dormers**

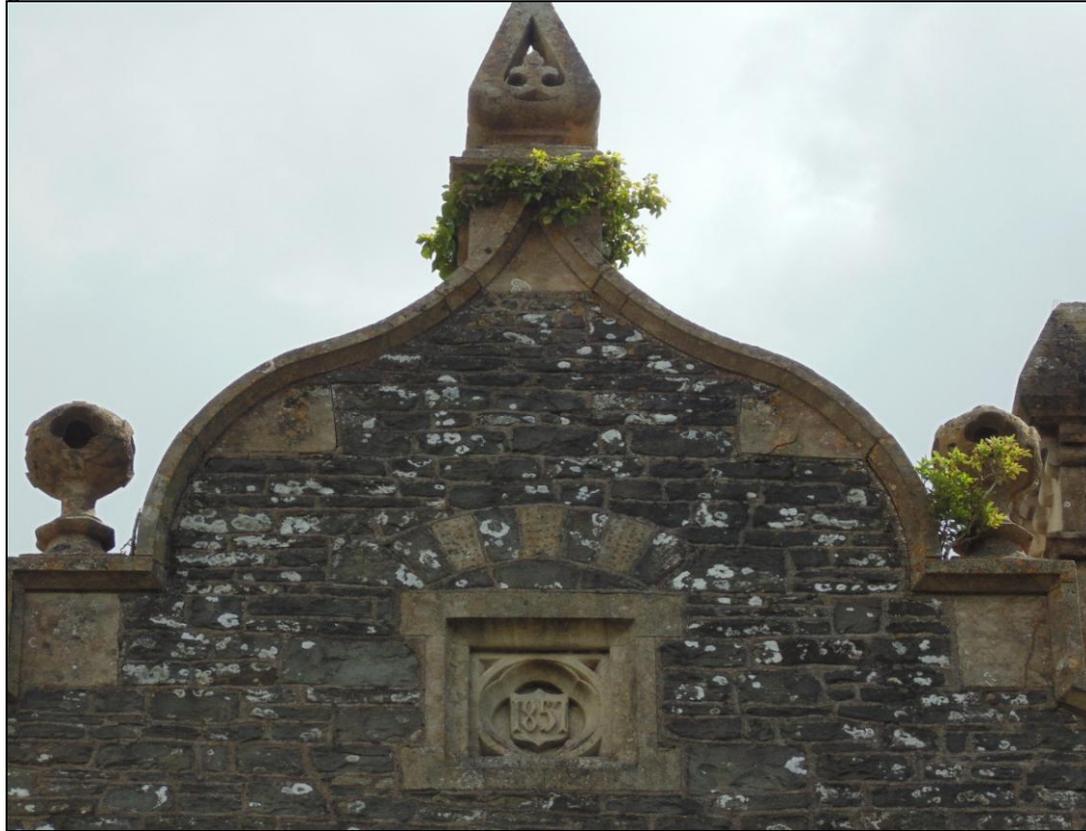
**Plant growth suggests open joints on stonework/copings of front gable**

Parapets on the front gable section showed evidence of open jointing which is allowing plant growth. Repointing of any open sections should be considered.

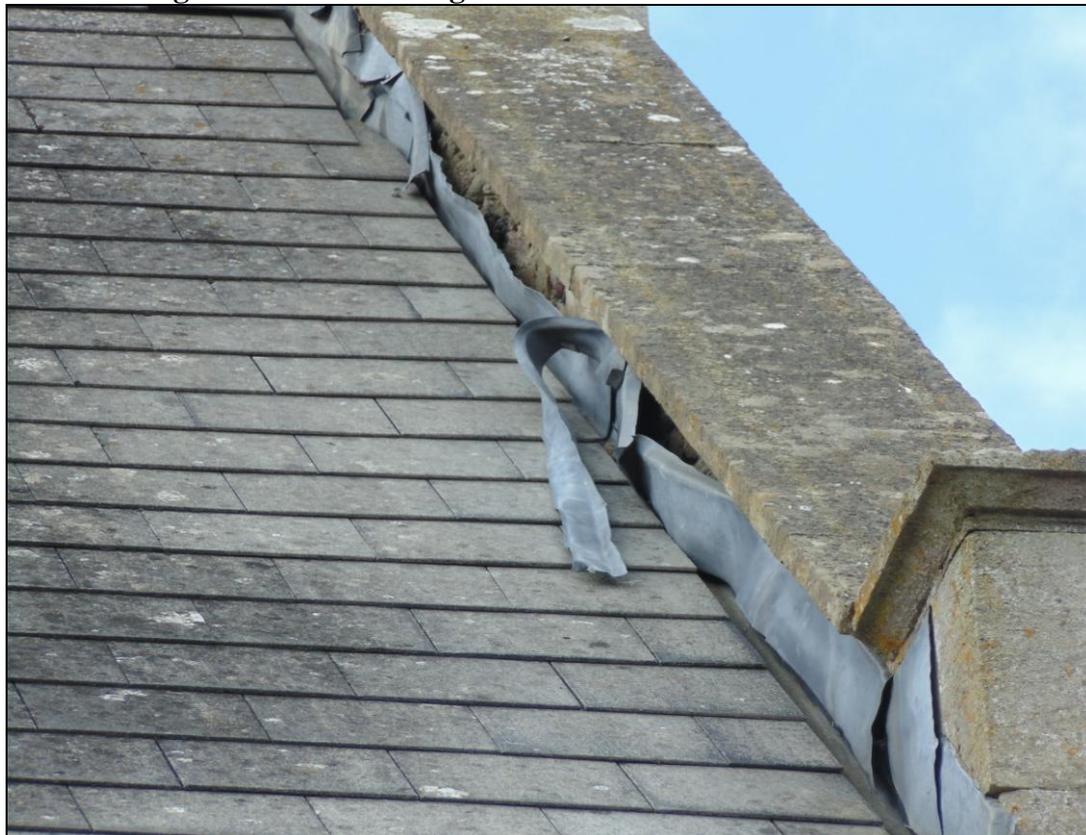
Parapets have been formed where main walls have been taken up above the line of roof level which can be seen on the rear courtroom part of the structure and, indeed, areas above the upper accommodation. The latter sections have been dressed with lead, presumably due to previously eroded coping stones. Lead work forming flashings with the rear parapet is particularly poor and requires replacement. This can be seen in adjacent photographs.

**Poor flashings on rear left hand gable**

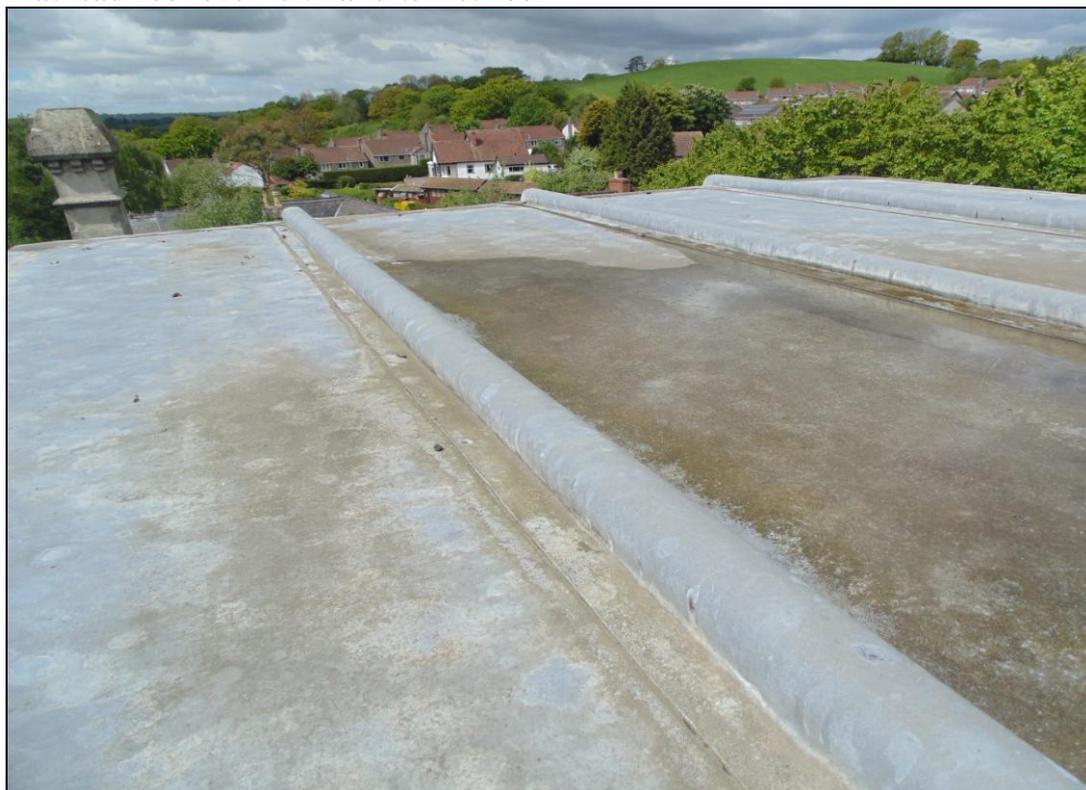
The left hand turret has a flat lead roof on timber framework. There was no indication of obvious deterioration noted externally and certainly no obvious sign of damp penetration below.

#### **Flat lead roof over left hand turret roof**

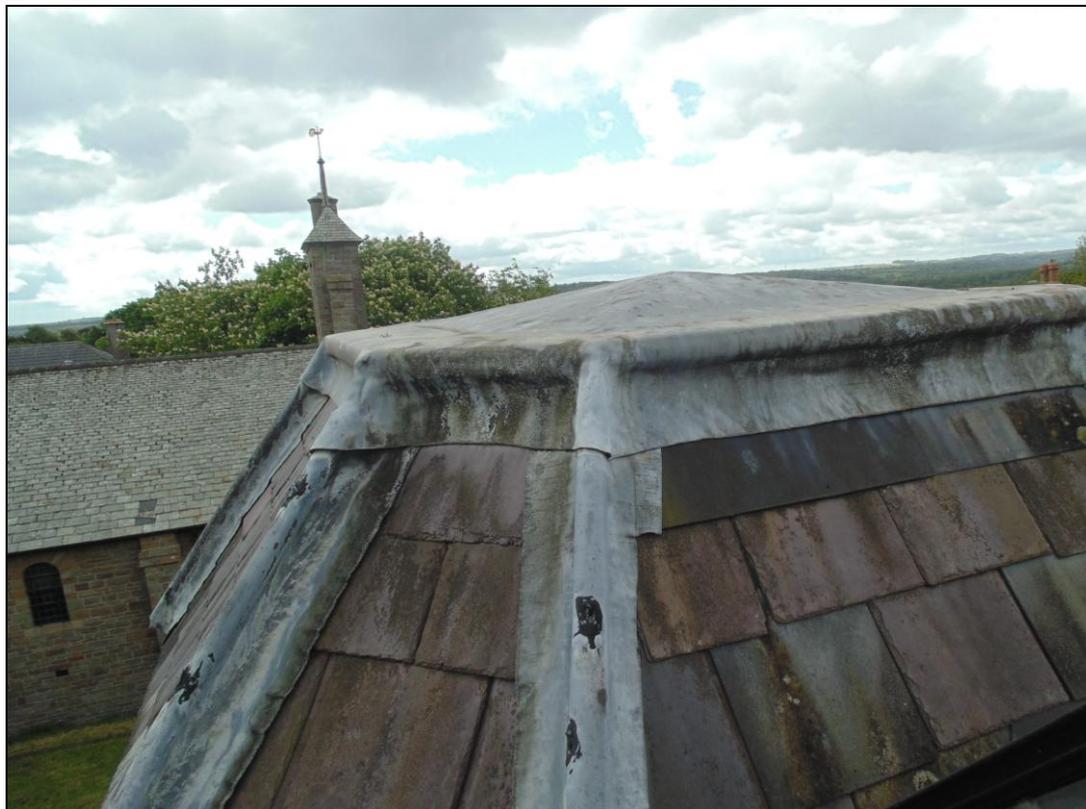
The right hand turret is part hip pitched leading to a larger lead covering. A number of slipped slates are present which should be refixed in conjunction with overhauling the main roof. Lead hip dressings are also dated and split in part and we suggest these be renewed.

**View of right hand “turret” roof – some poor lead dressing noted**

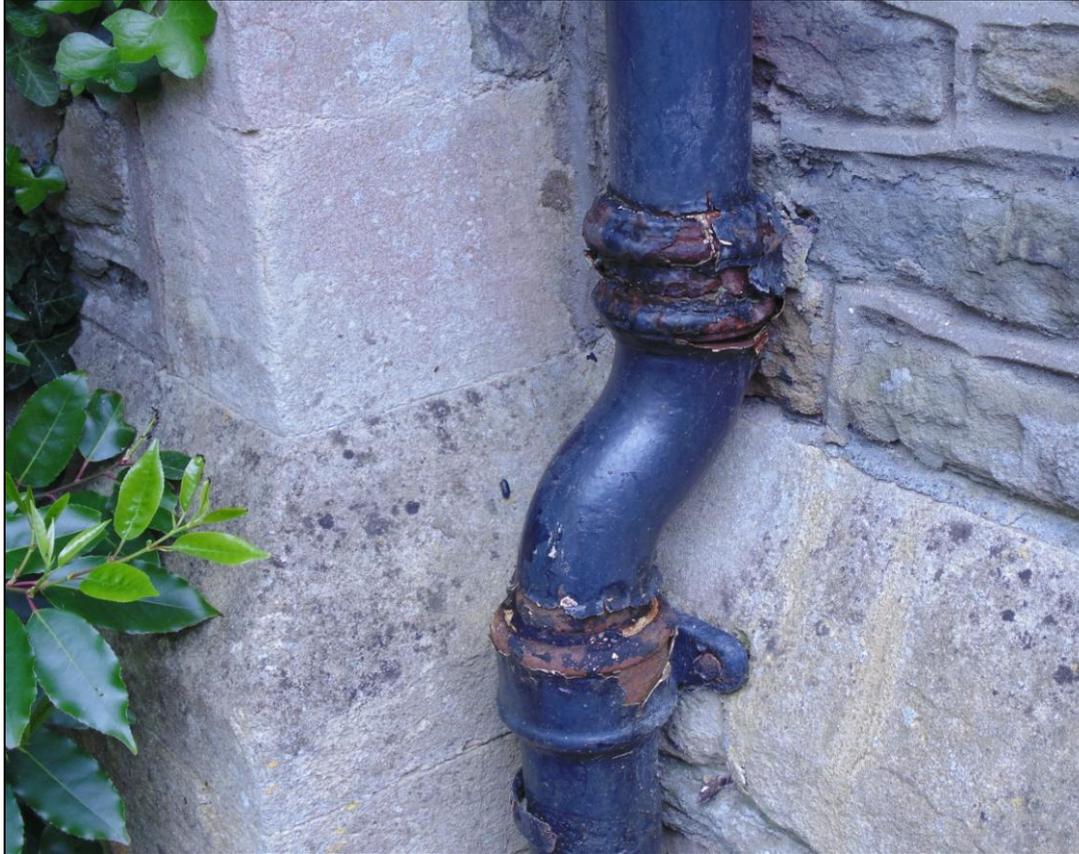
Other rainwater goods comprise PVC and metal gutters leading to metal downpipes. It is clear that a number of the rainwater goods are in poor condition and overhaul is now recommended.

**Poor downpipes require repair**

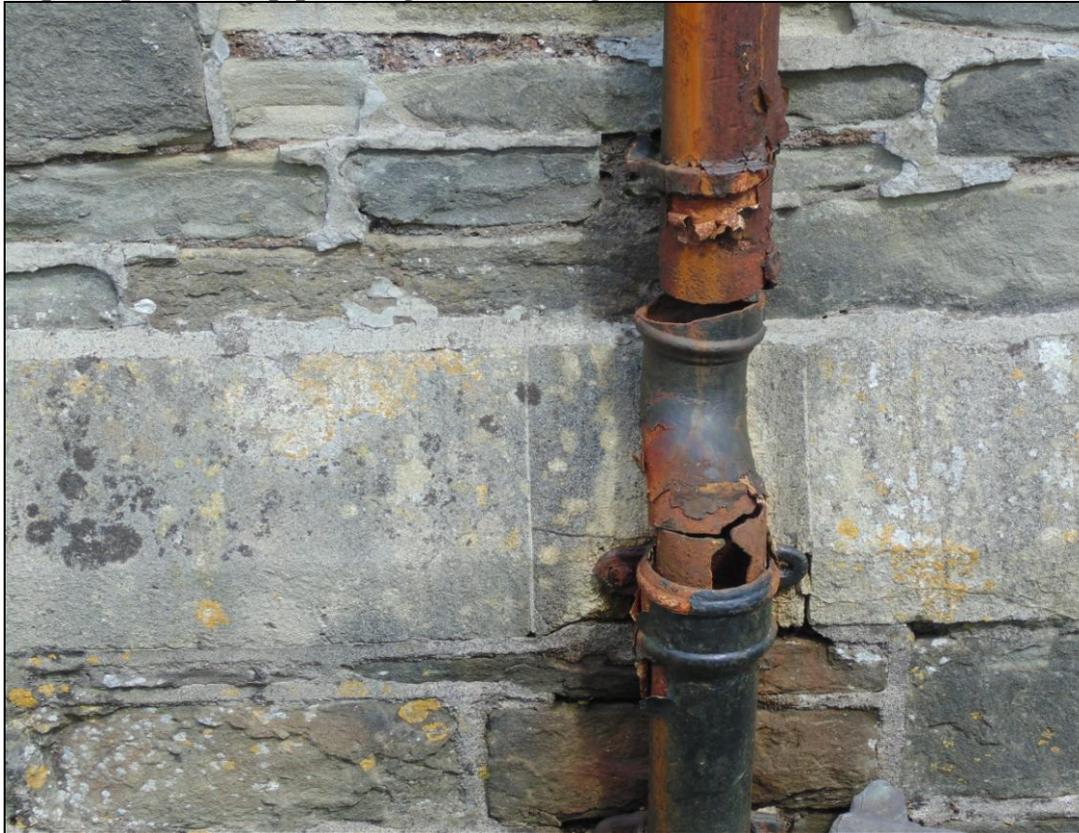
Corrosion was noted on the right hand downpipe which can be seen in adjacent photographs and this is clearly in poor condition and requires replacement. This downpipe now also appears to be partly blocked in the upper parts which is allowing overflow and subsequent staining of stonework. Other surface corrosion and splitting is present to the downpipes which is allowing a degree of leaking at joints which can certainly be seen on the front and left hand side of the building. Rubbing down, treatment with rust inhibiting primer and redecoration of these areas will be required.

**Replace poor downpipe on right of building**

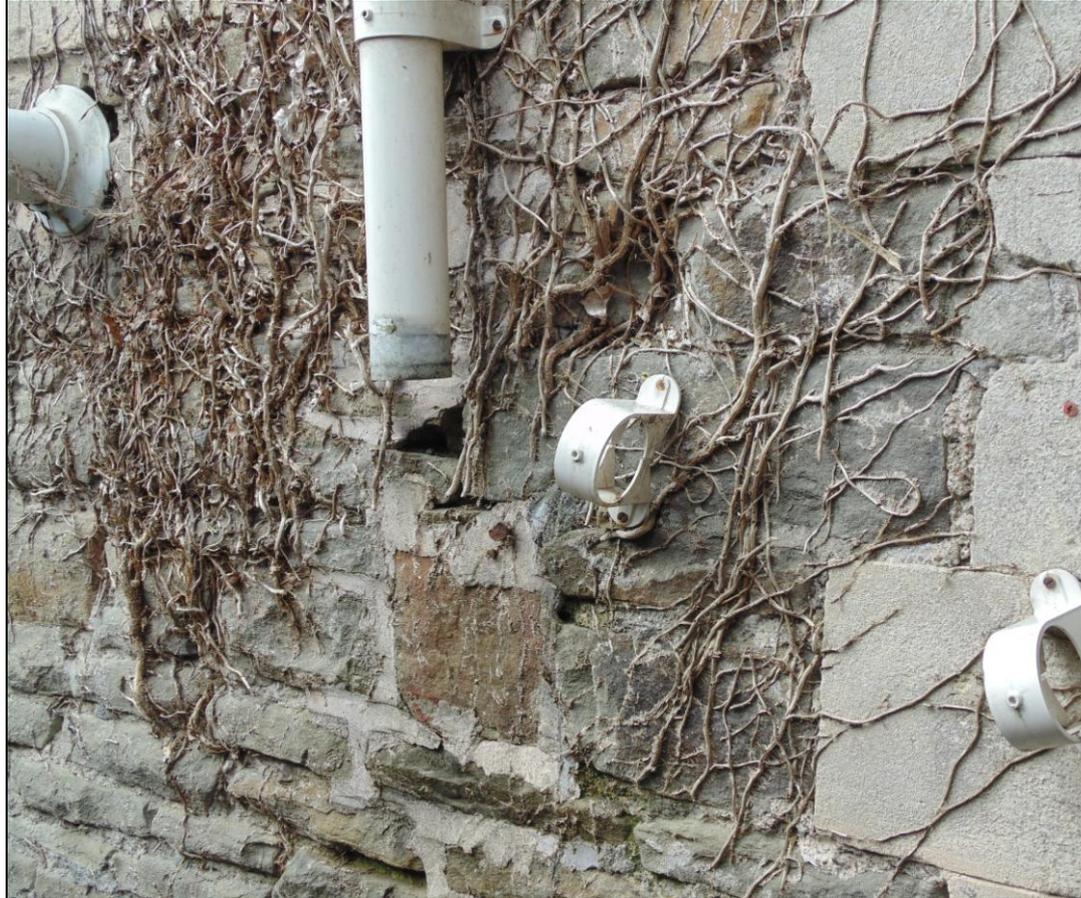
The rear PVC downpipe is partly missing and refixing is required. This should be channelled to a gulley to take water away from walkways. We did note that the gulley which previously served this appeared to be blocked and this should be cleared out.

#### **Missing downpipe on rear**

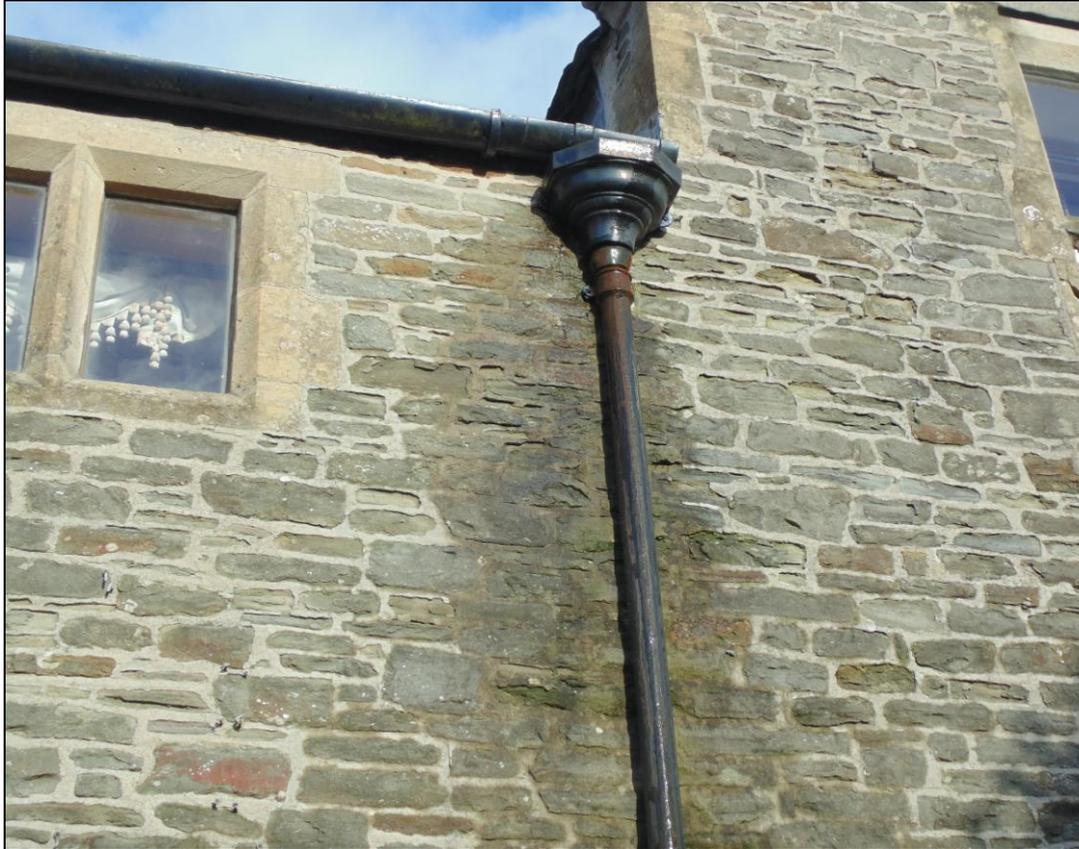
**Leaking/overflow downpipe causing staining of stonework**

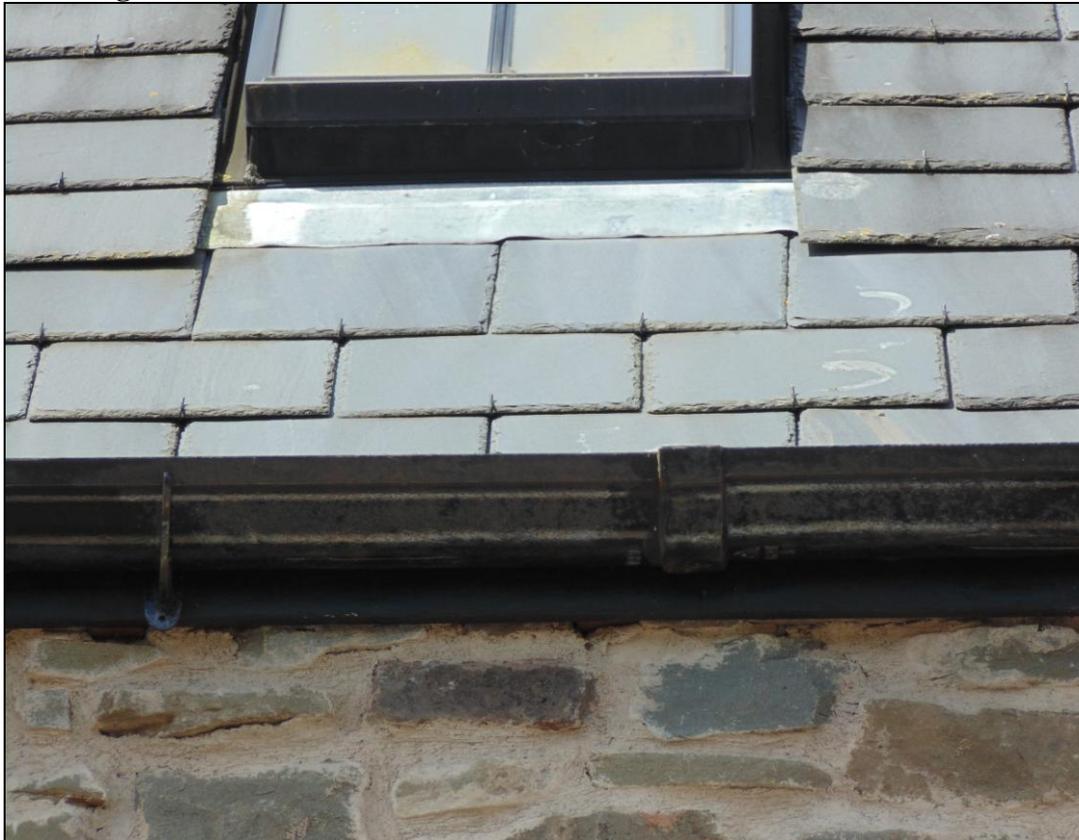
Some uneven gutters are also present with examples including the rear right hand areas and, indeed, parts of the extension. Where uneven parts are present, taking down and realignment would be prudent.

**Uneven gutter on rear of extension**

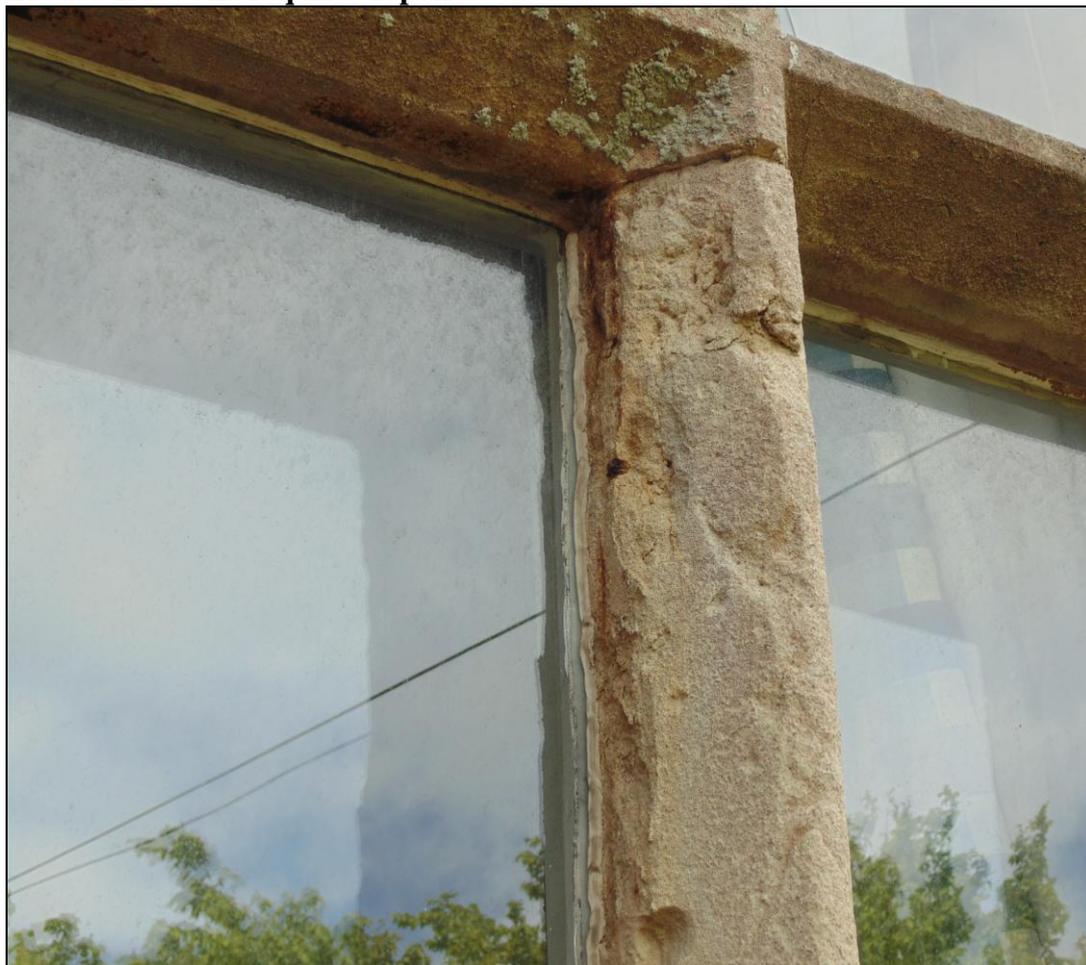
Freestone dressings have, inevitably, been subject to a degree of erosion in the past with perhaps the most obvious being transoms serving the windows. Examples of deteriorating stonework can be seen on the left of the main building together with the front. These clearly require reforming. Areas of glass were noted below front transoms although we are unsure as to their purpose. Minor damaged sections are present which you may wish to repair.

### **Eroded freestone requires repair**

**Action: Obtain estimates for repair of external stonework in terms of reforming areas of eroded freestone together with repointing as necessary.**

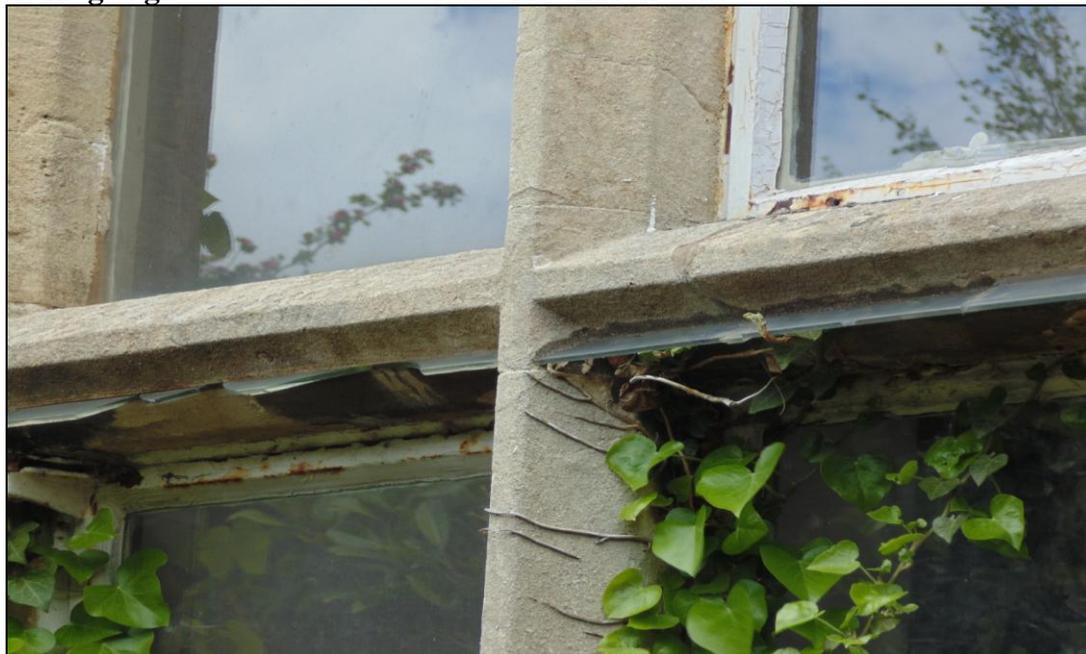
### **Damaged glass sections below transoms on front windows**

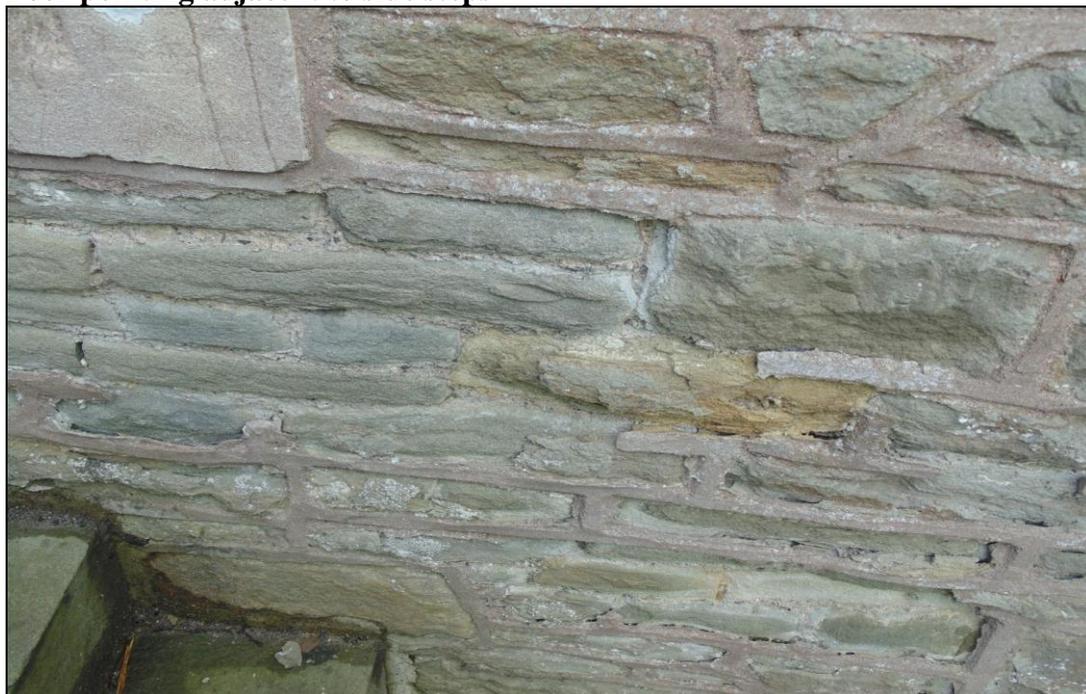
There are areas of deterioration to the mortar pointing between many parts of the stonework where raking out and patch pointing is now a requirement. Examples can certainly be seen adjacent to the left hand entrance steps, parts of the smaller left hand gable together with parts of the larger left hand gable. There is also deterioration to pointing on the right and front together with slight delamination of random pennant stonework and this highlights the importance of regular maintenance in relation to exterior parts.

### **Poor pointing adjacent to side steps**

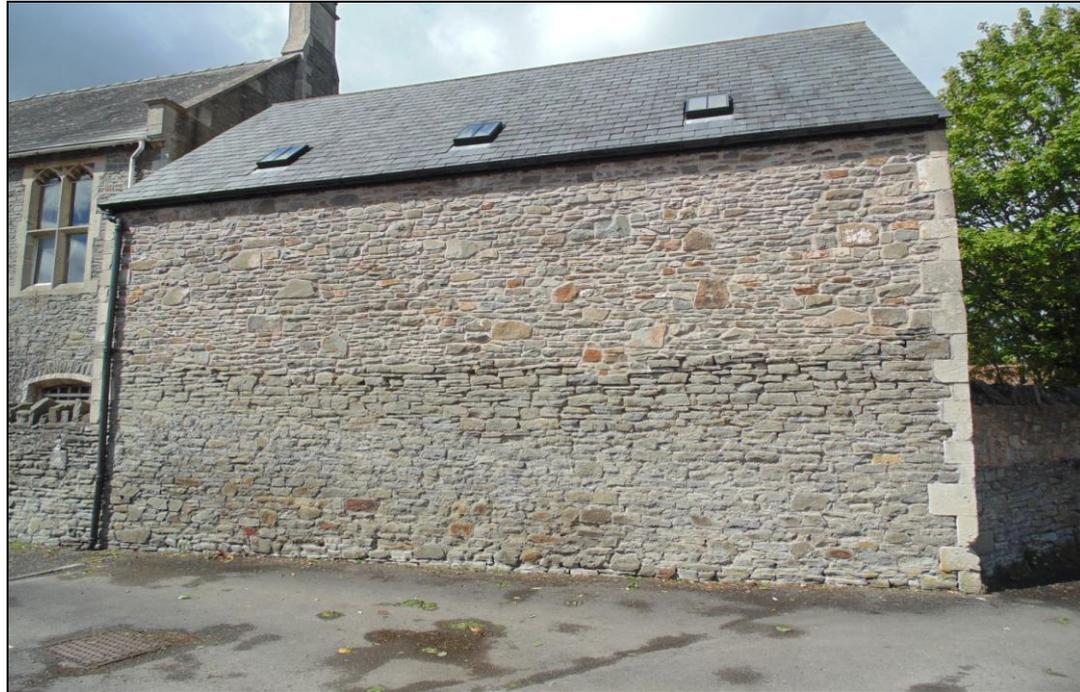
The extension comprises stonework together with blockwork which may contain elements of cavity design. There is a slight disparity between the original part of the building and more modern stonework which has been used. Some deterioration is present to pointing and also minor erosion/damage to corner quoin work where repairs should be undertaken.

**Modern/old stonework on rear of extension**

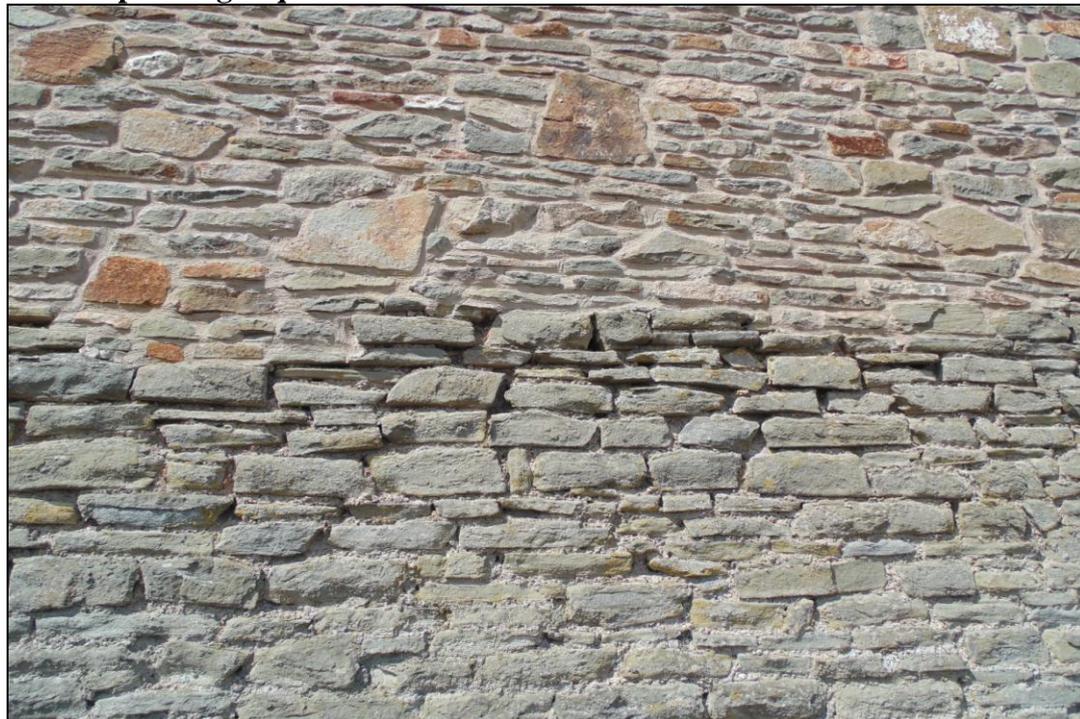
**Some repointing required on extension**

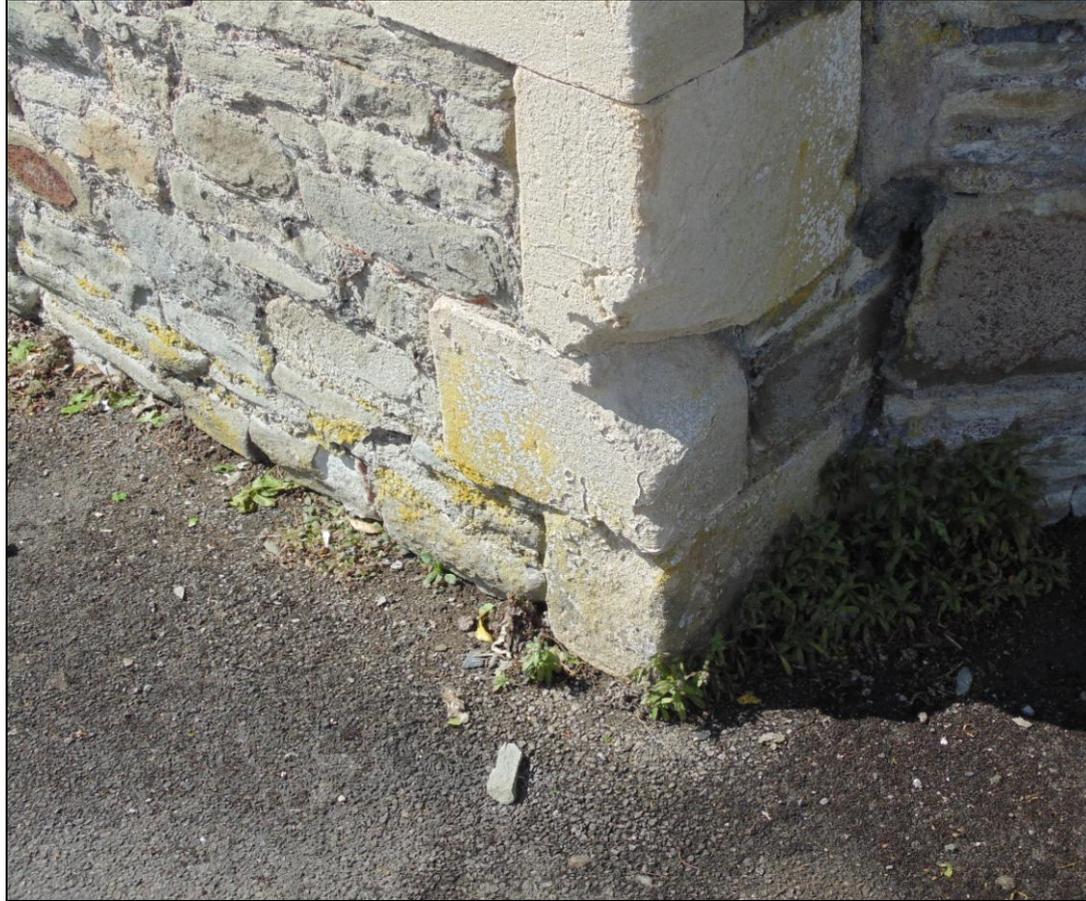
### Repairs to quoin work of extension recommended

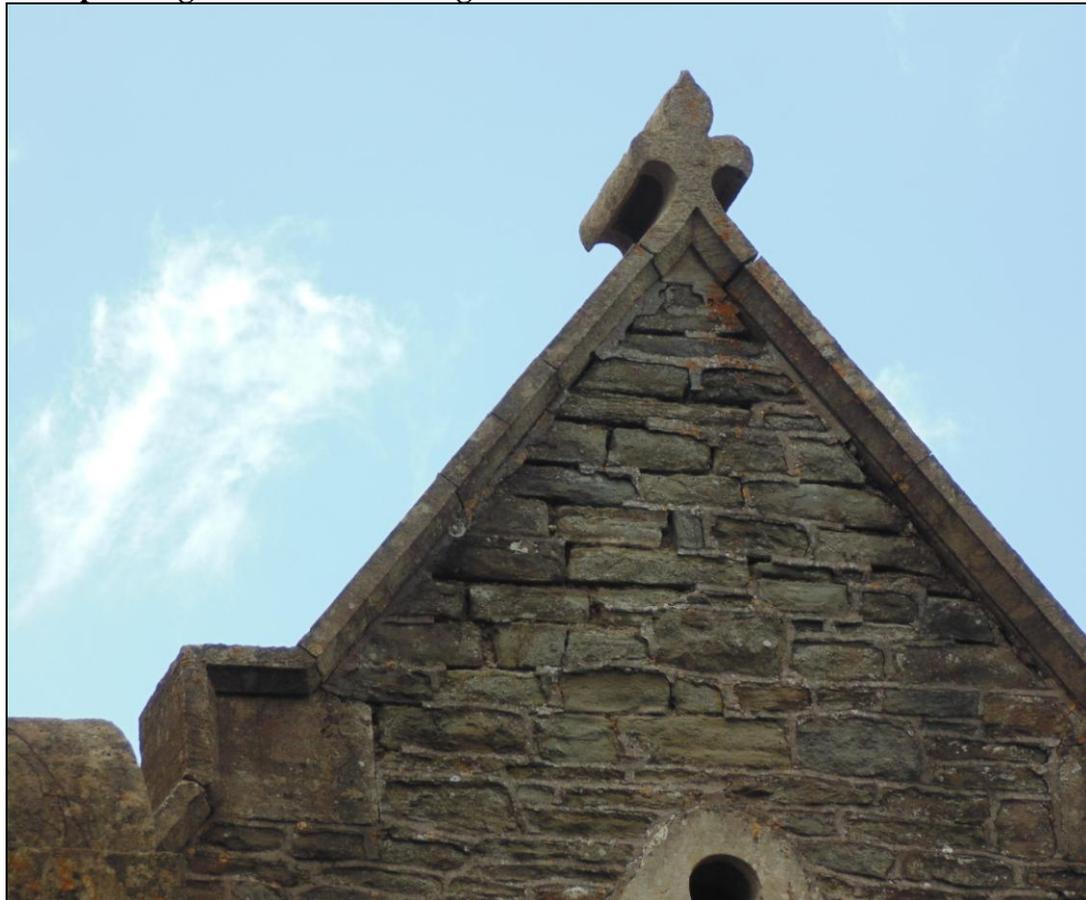
### **Poor pointing on small left hand gable**
