**FULL BUILDING SURVEY**

**Lynbrook House  
Stocks Lane  
Bristol  
BS14 7DG**

**10 October 2016**

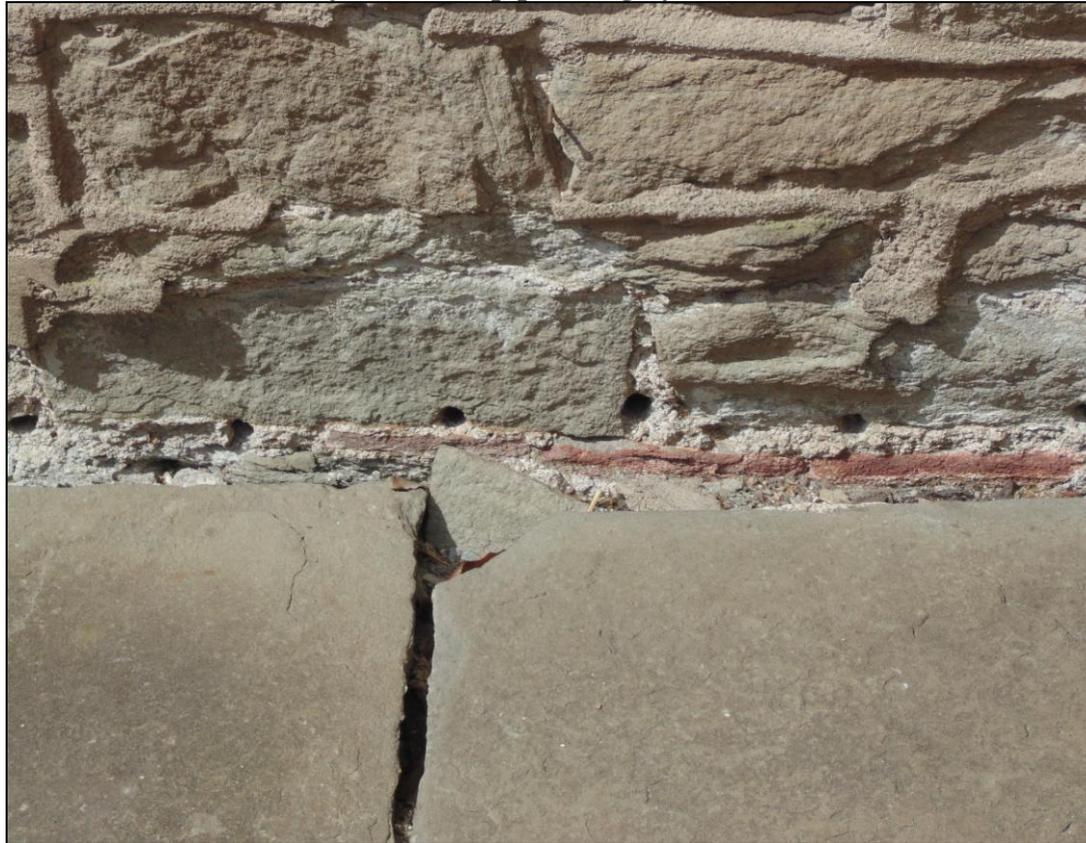
### **Evidence of chemical injection damp proofing by kitchen**

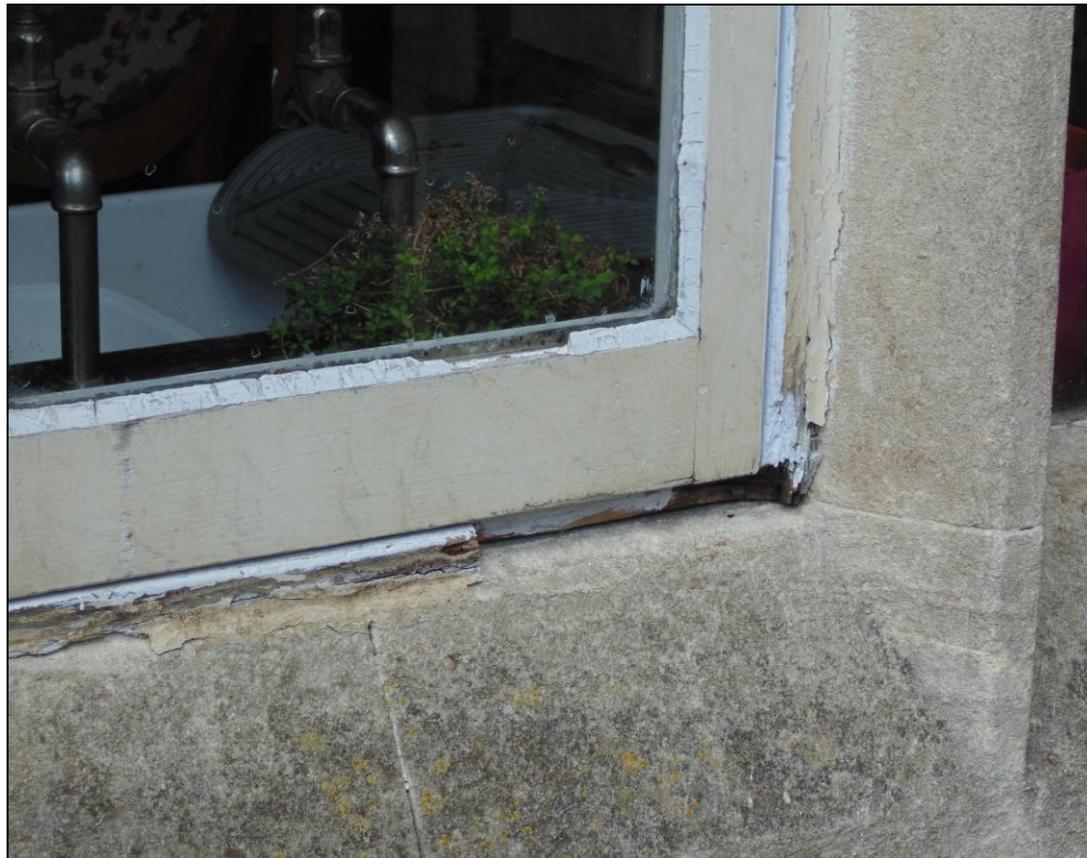
The timber casement windows serving the kitchen showed evidence of rot and cutting out and replacement of any defective sections would be prudent.

### **Rot noted to kitchen window**

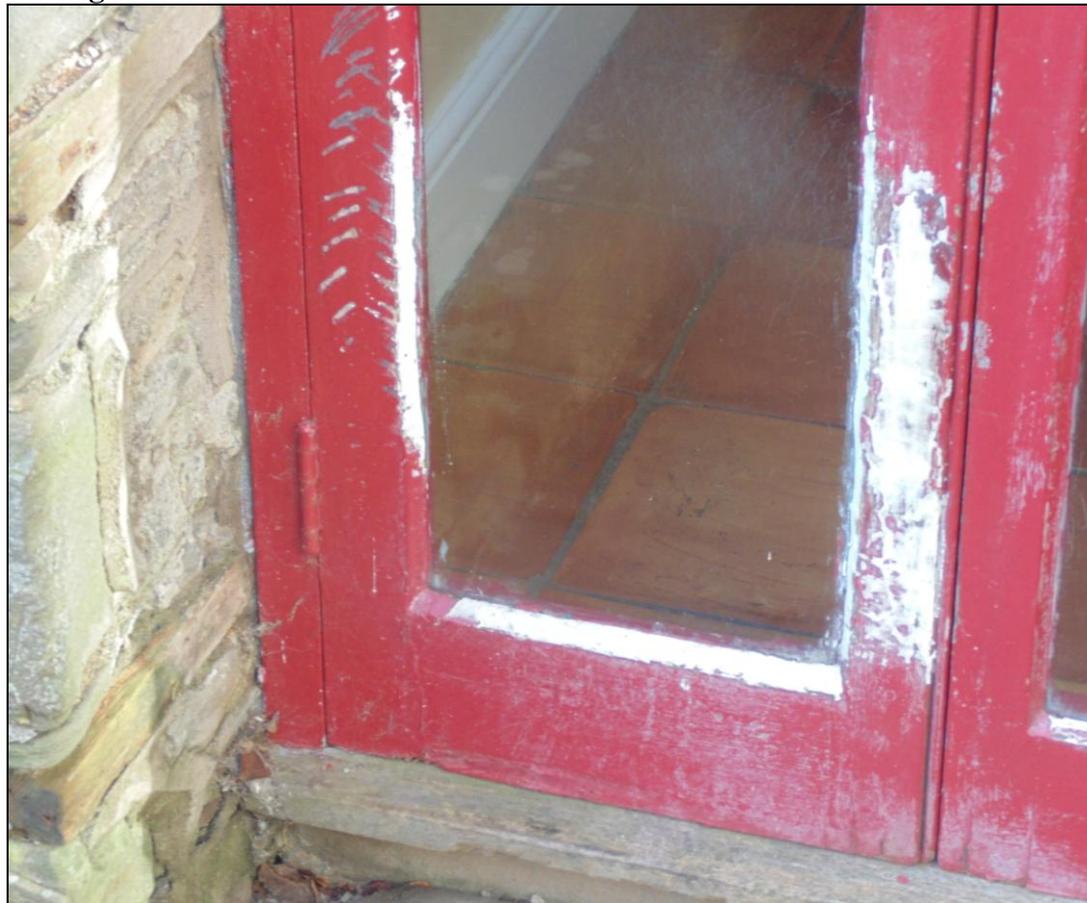
Timber part glazed doors are present from the kitchen which have been partly damaged by a family pet and repair will be required. There is a timber stable door from the utility and also timber door from the “jail cells”. Rot was noted which should be overhauled.

#### **Damage noted to kitchen door**

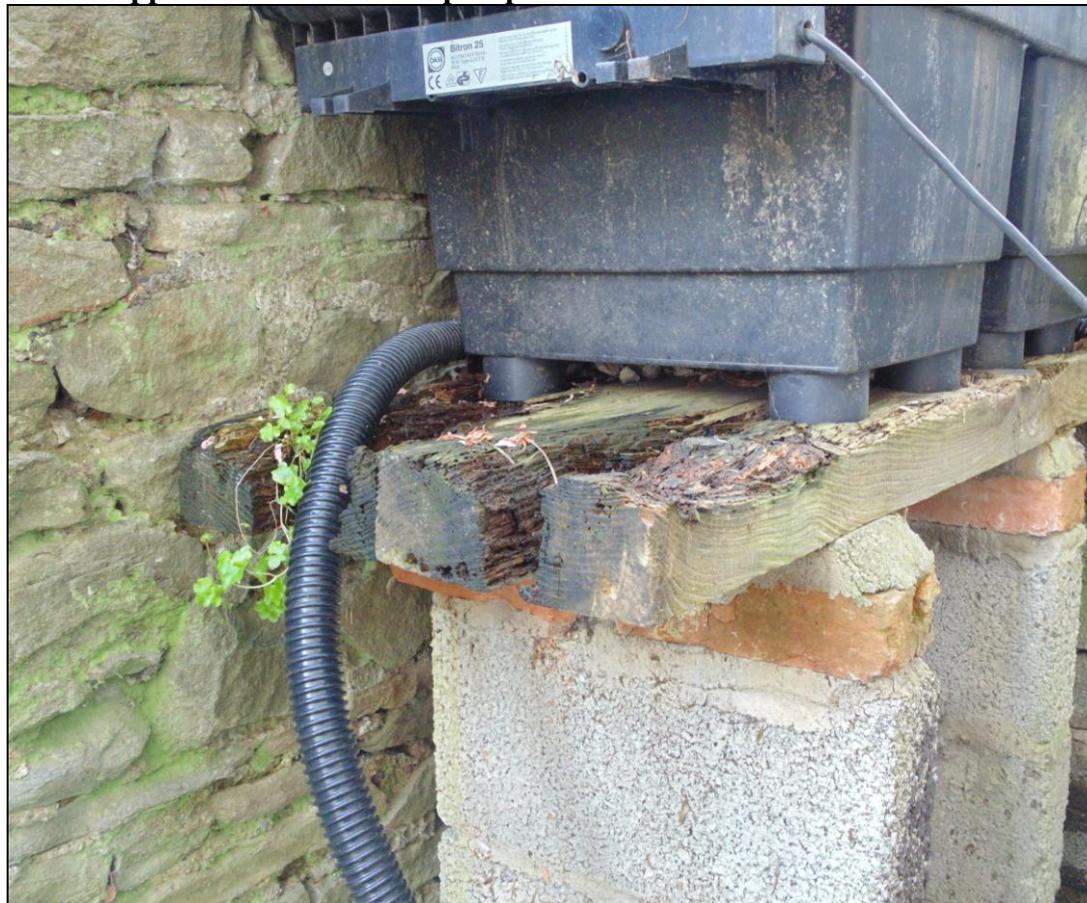
There is a water feature on the right hand side of the site which was an attractive addition. Rot was noted to timbers holding up the pump section which will require repair. There are also some leaking sections visible from the small rear path area adjacent to the damaged manhole cover and improvements should be considered.

### **Rot to support of water feature pump**

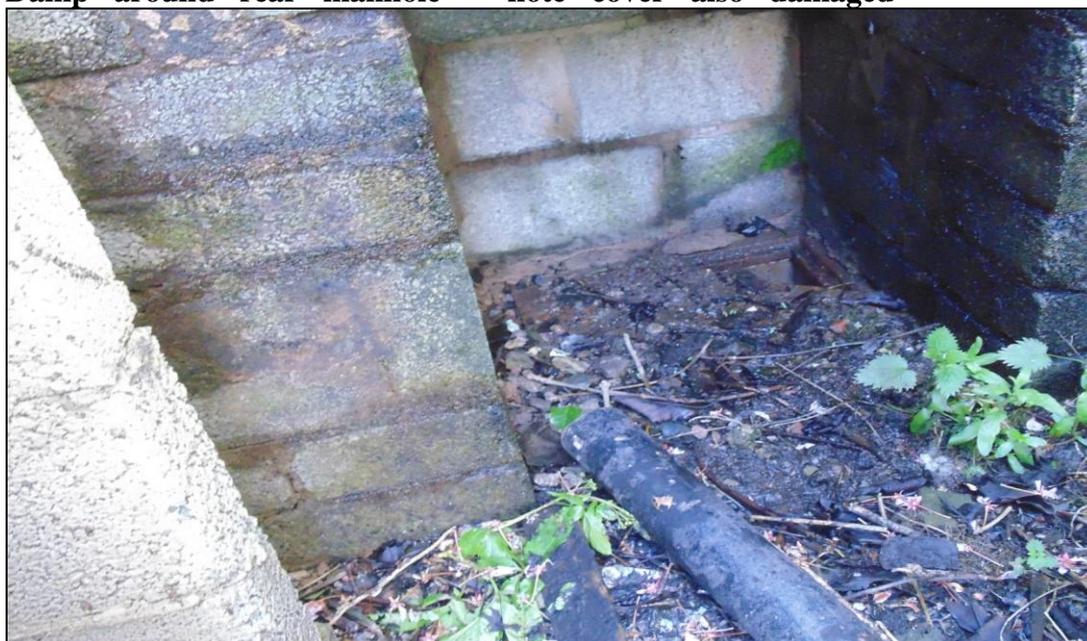
### **Damp around rear manhole – note cover also damaged**

The damaged manhole cover at the rear should be renewed.

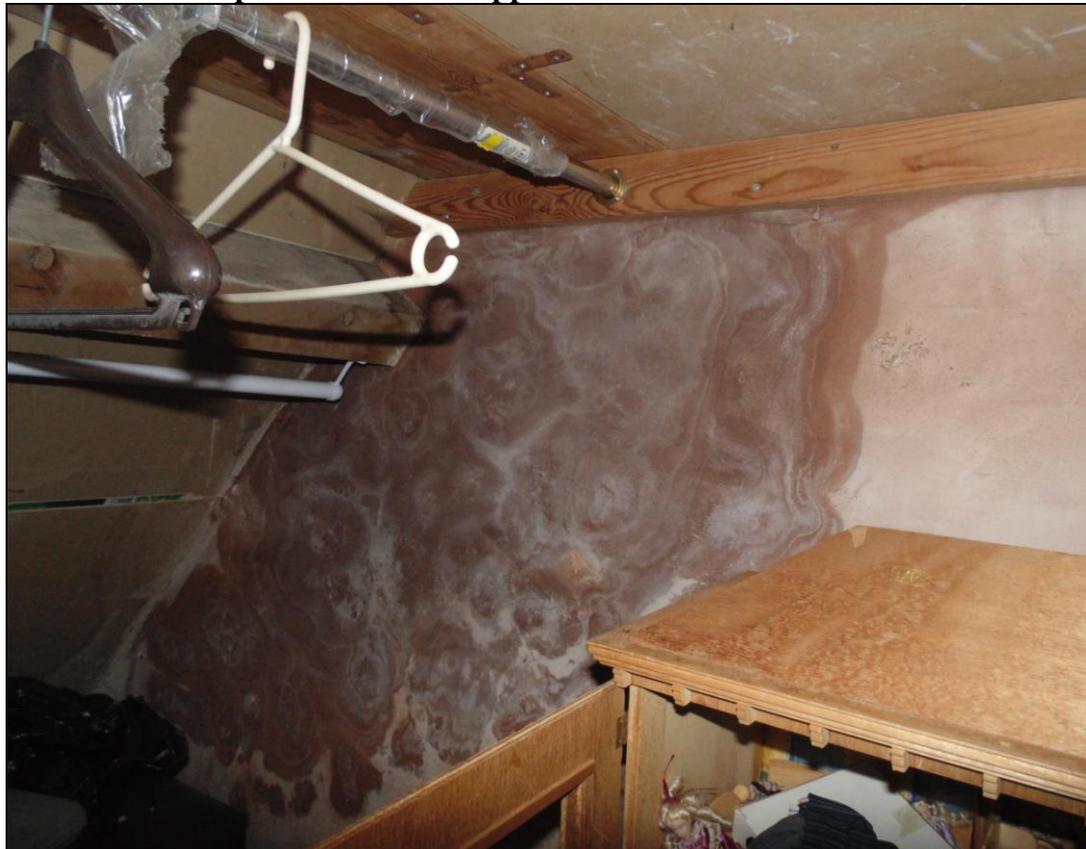
Dampness was noted in the boarded out roof void which can be seen in adjacent photographs. External repairs are required to roofs and chimney stacks as previously mentioned together with repointing of the gable immediately adjacent to the damp itself. Failure to do so will allow further water penetration which could encourage rot in adjacent timbers.

**Evidence of damp in roof void off upper accommodation**

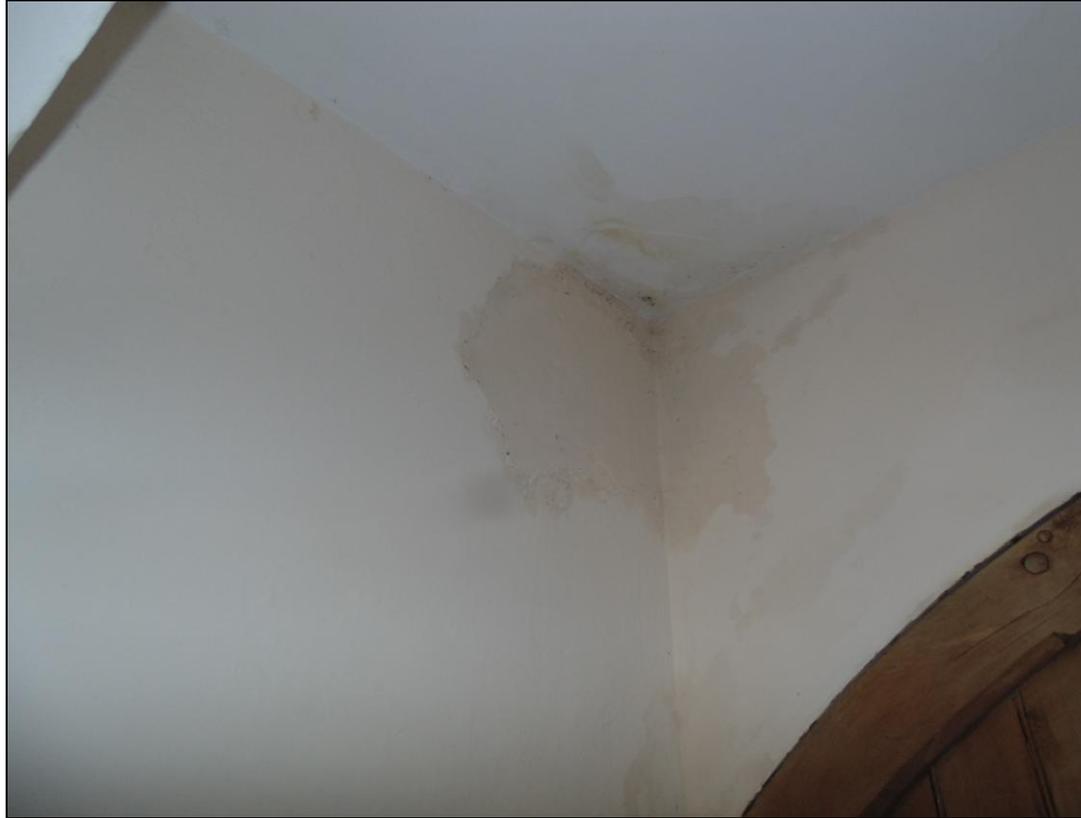
### **Damp in upper side entrance**

**Action: Instruct a suitably competent damp treatment specialist to carry out an inspection of the property and provide estimates for repair of any internal dampness.**

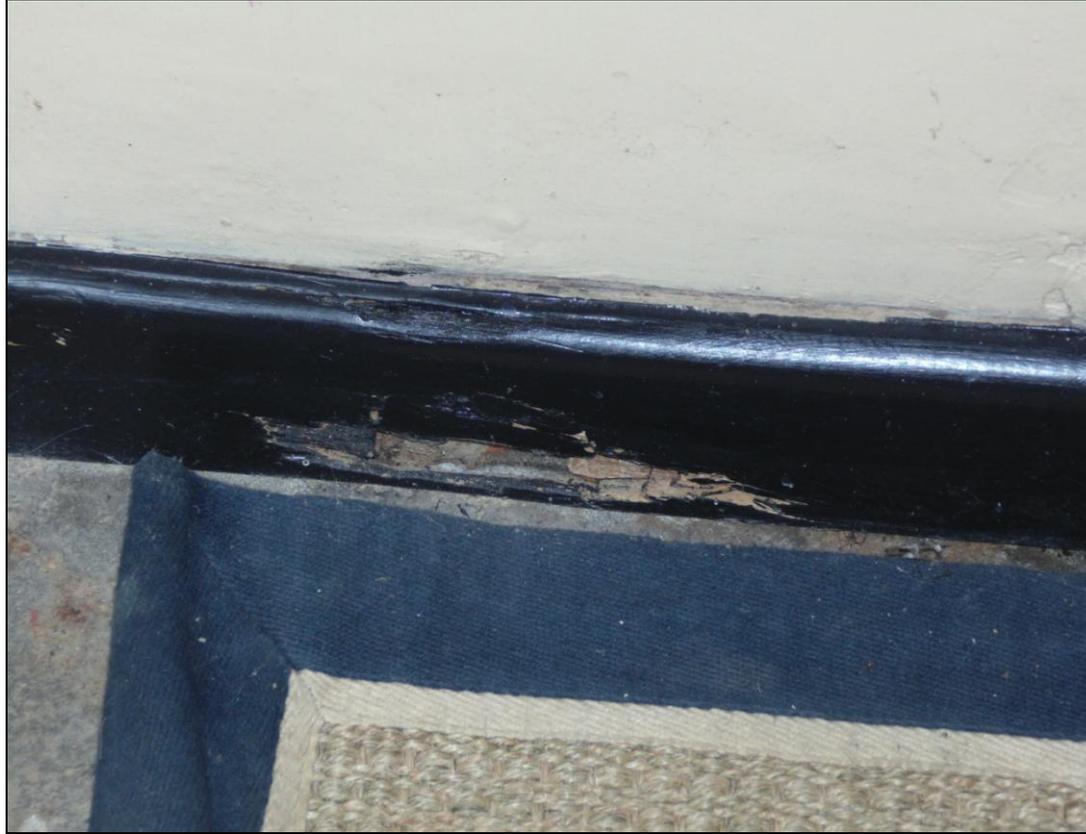
### **Rot noted to skirtings by “jail” exit door**

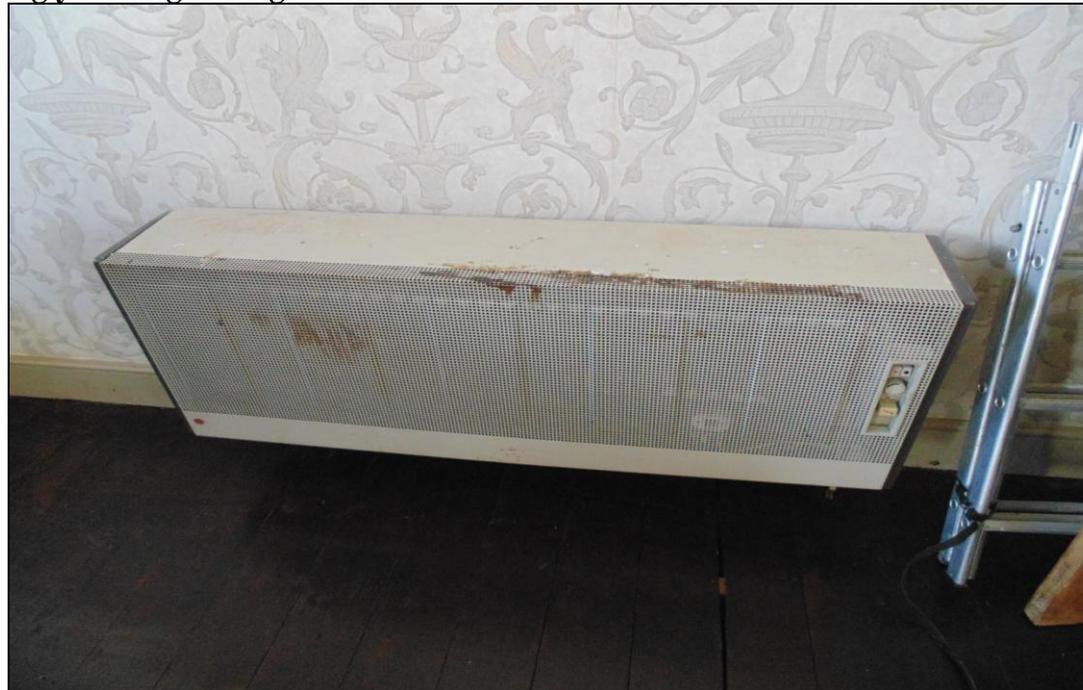
### **Ugly heating arrangement in Court Room**
