**FULL BUILDING SURVEY**

**Lynbrook House  
Stocks Lane  
Bristol  
BS14 7DG**

**10 October 2016**

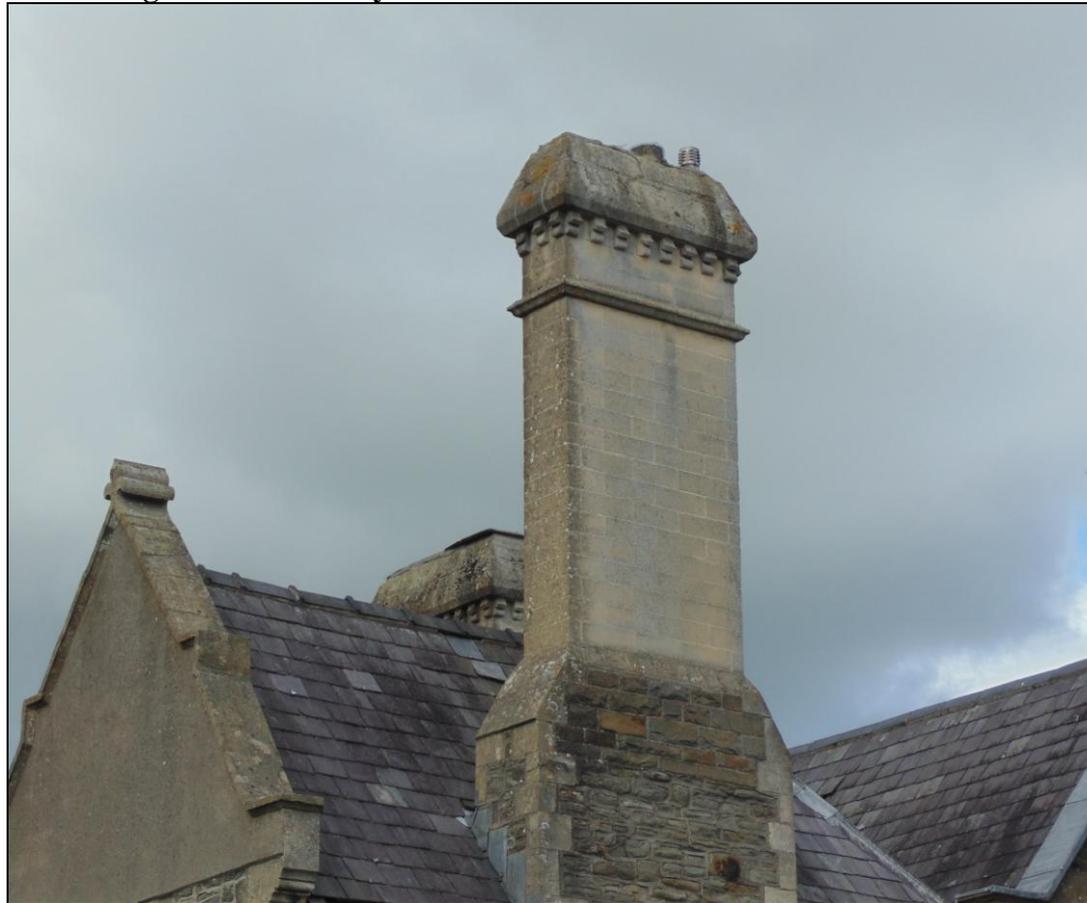
There are some seven chimney stacks serving the building which were viewed from our vantage point at ground level using binoculars although a closer inspection of some elevations was possible from the main roof area. There are two stacks on the left, three on the right together with two central stacks. All of the structures are of traditional stone construction with lead flashings and soakers at the joint with adjacent roof slopes.

#### **View of right hand chimney stack**

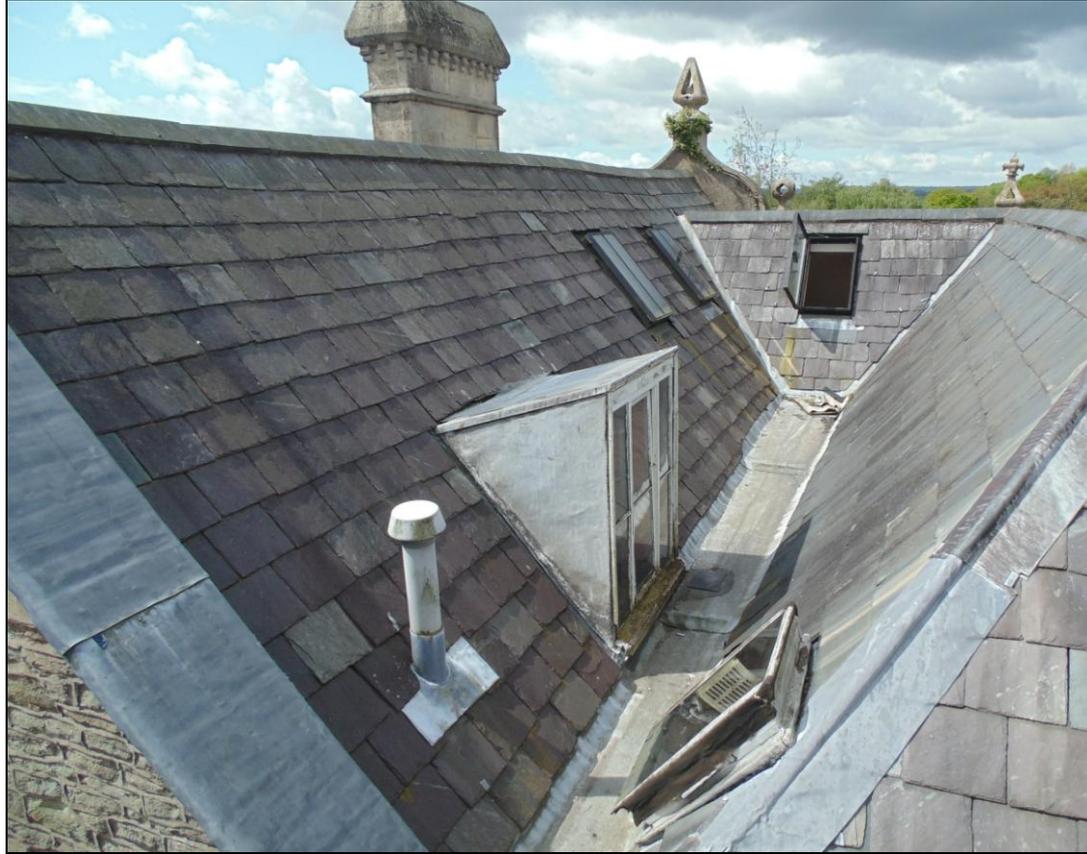
**View of central valley roof slopes**

There is a central valley area on the main roof which leads to a secondary valley taking water to the right hand side of the building. Coverings comprise lead work which is typical of a building of this age and design. The main central valley was in satisfactory condition and no obvious leaking was noted below. The secondary valley did show evidence of some sludge build up and this clearly requires clearing out. This may have occurred due to a fairly shallow gradient and it will not be easy to redesign should you wish to do so. This will naturally require the regular inspection of valleys and cleaning out of debris to allow water to channel to ground level appropriately. There are also a number of sloping valleys at the intersection of roof slopes, again, lined with lead work. Sloping and horizontal valleys are notoriously prone to blockage and deterioration and can be a frequent source of water penetration internally. Whilst we found no indication of leaking, regular checks on lining materials will be required with any blockage removed as soon as possible.

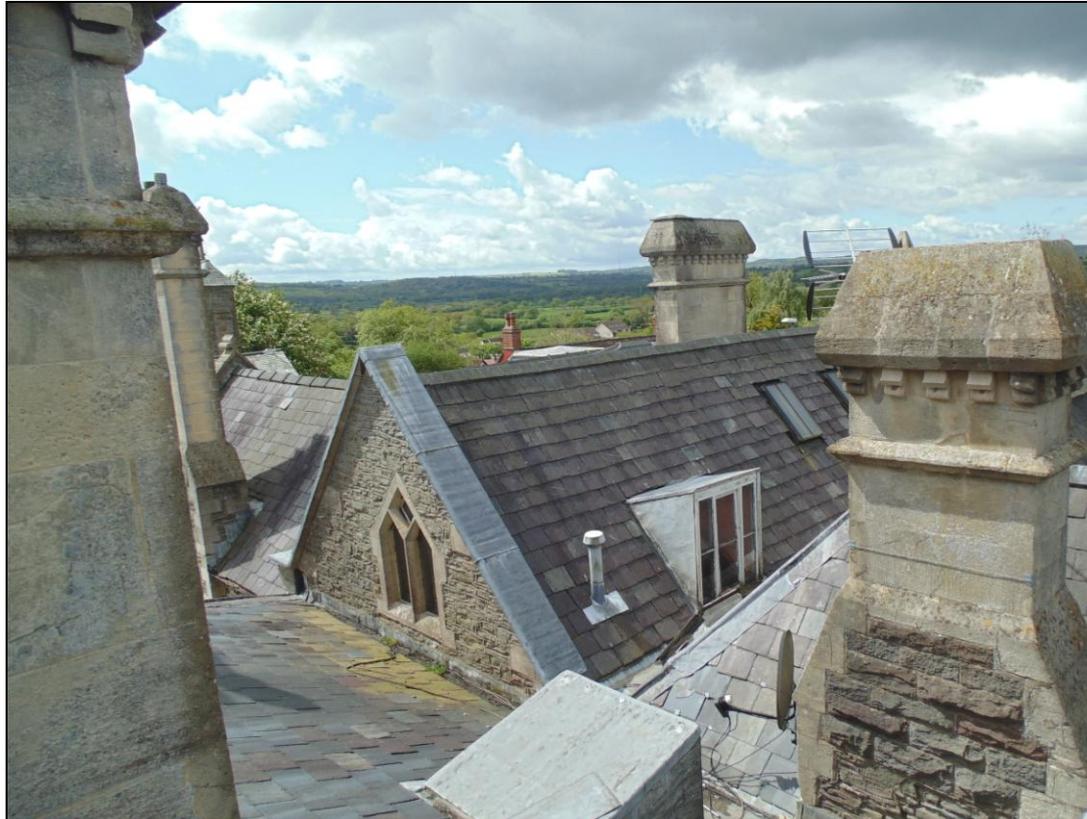
**Further view of roofs**

During the survey we found no indication of sag or deflection to the roof slopes suggesting that the supporting timbers are of a suitable size to carry the imposed load upon them. The ridge sections showed evidence of minor undulation although this is certainly not excessive with distortions considered to be within acceptable limits.

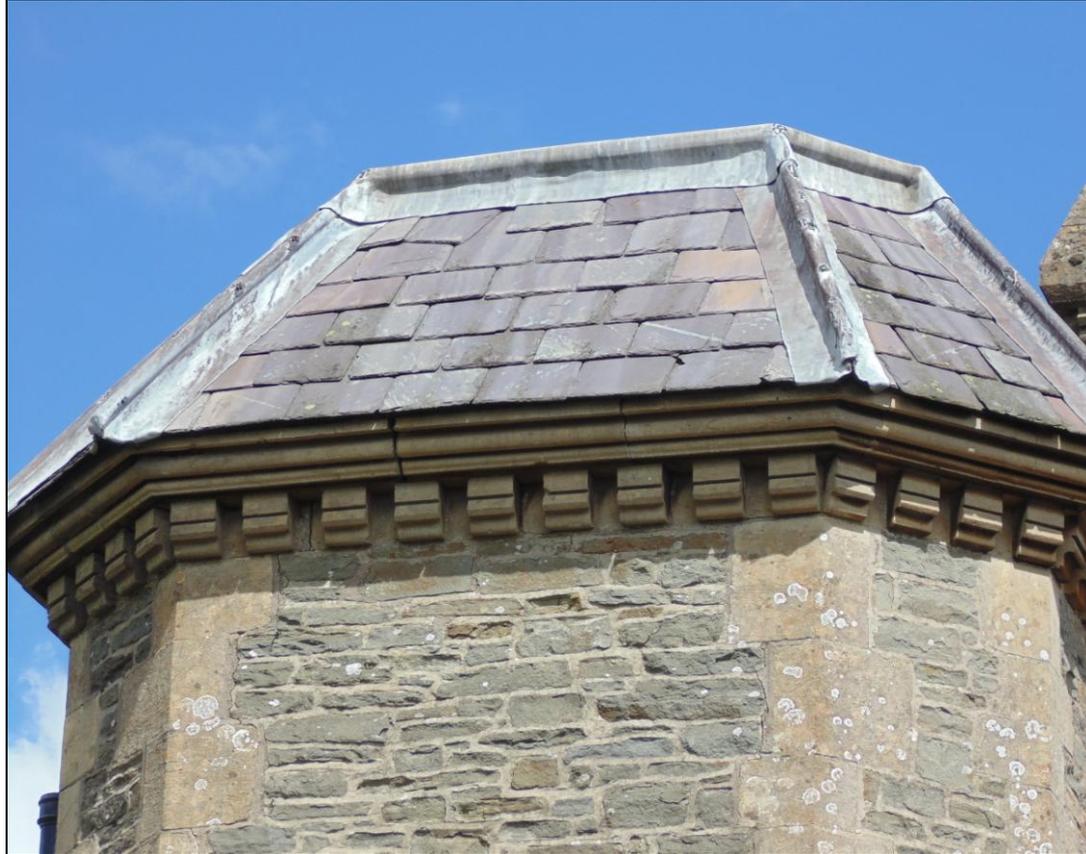
**View of right hand “turret”**

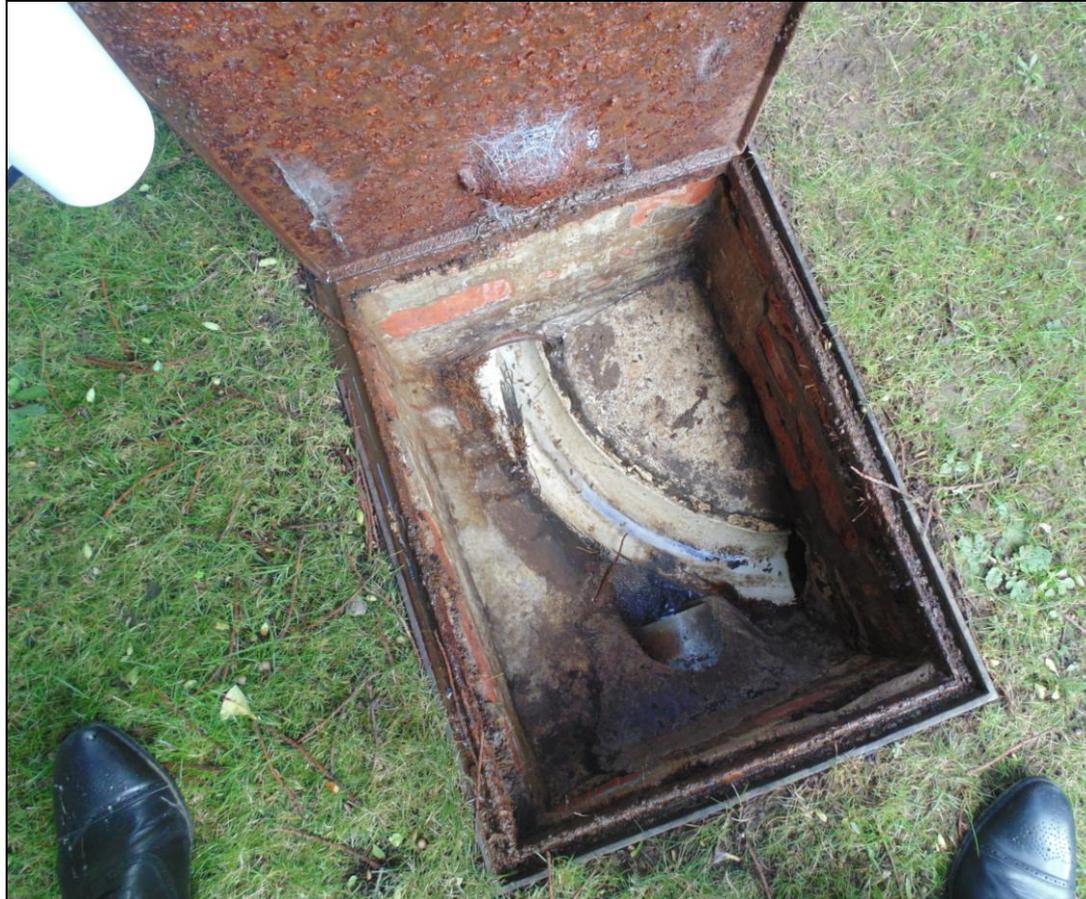
**Drainage chamber free from blockage**

**Action:** We recommend a pre-purchase drainage test be undertaken in the normal way preferably prior to exchange of contracts.

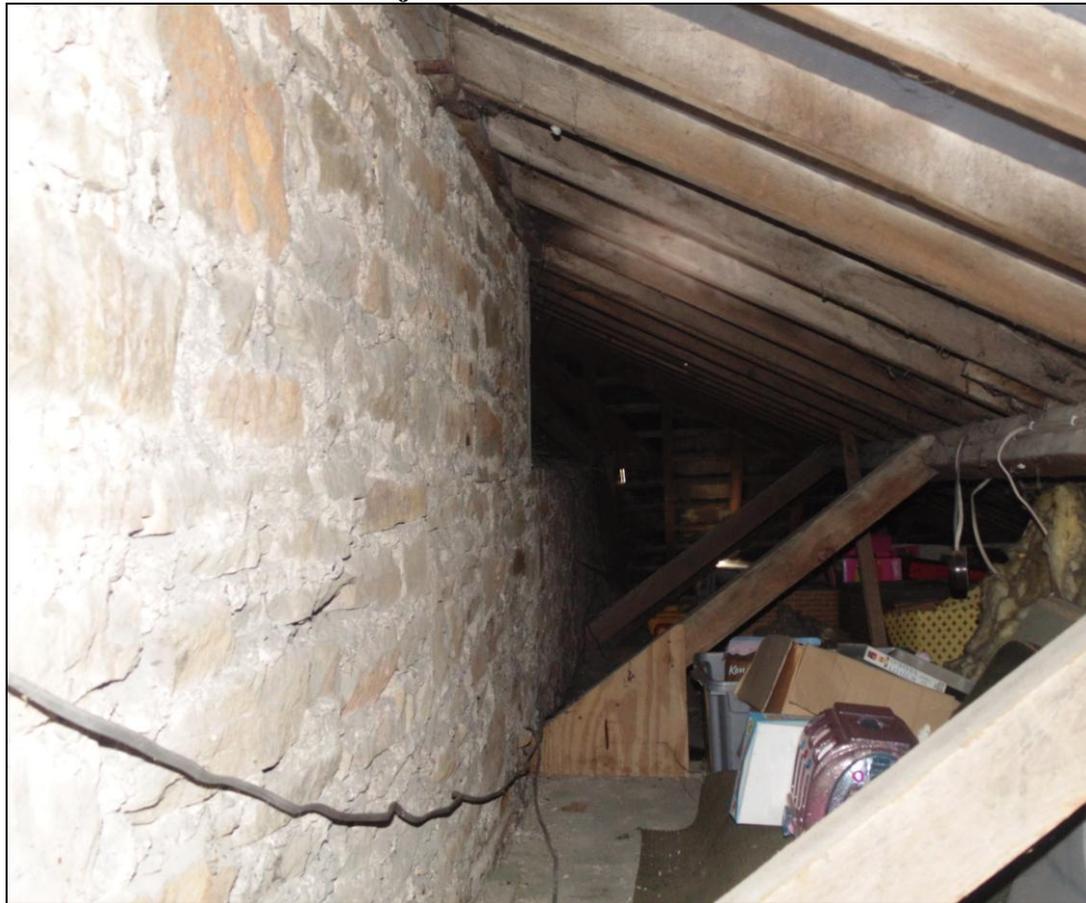
### **Small roof void accessible adjacent to sauna stairs**

Access was possible to a roof void adjacent to the steps leading to the sauna together with the right hand turret void. There is also a boarded out void accessible from the upper accommodation.

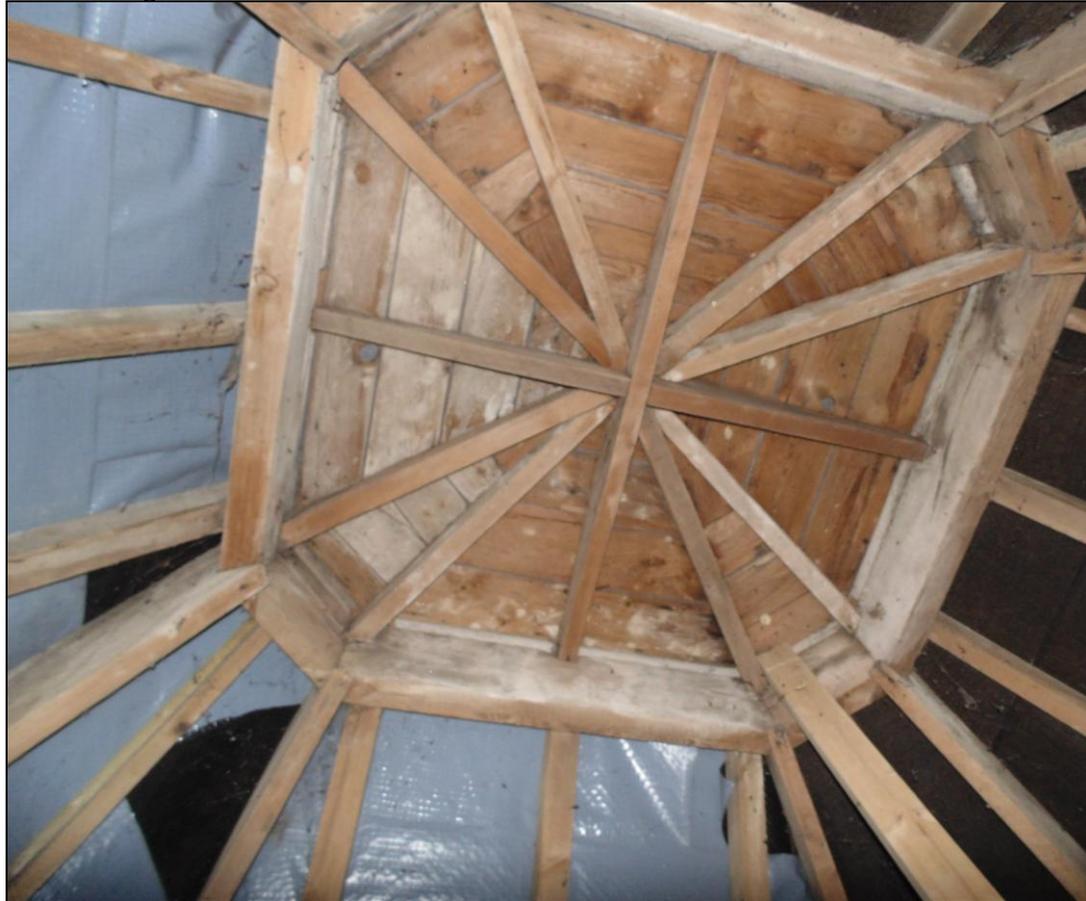
### View of right hand turret roof

Structural supporting timbers comprise rafters laid upon cross supporting purlins (where visible) together with ridge, valley and hip boards. There are, inevitably, one or two split timbers including rafters although this appears to be superficial rather than structural in nature. Timbers are considered to be appropriate to carry the imposed load upon them.

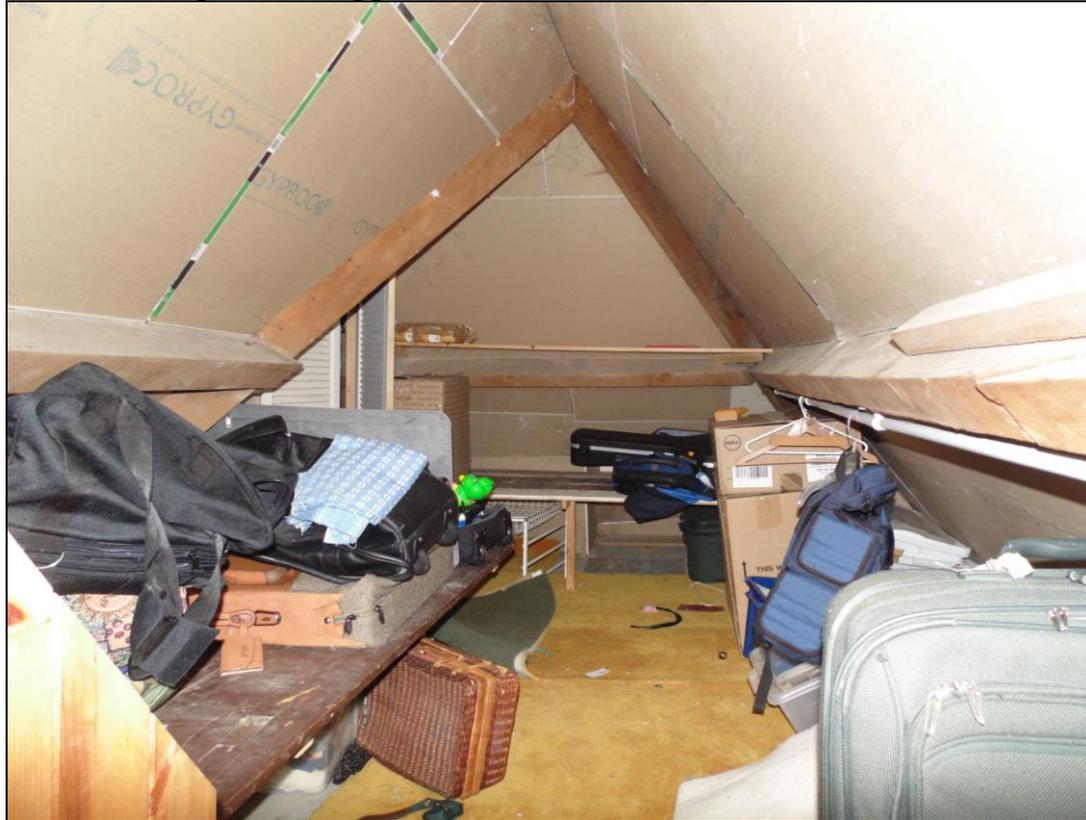
Dampness was noted in the boarded out roof void which can be seen in adjacent photographs. External repairs are required to roofs and chimney stacks as previously mentioned together with repointing of the gable immediately adjacent to the damp itself. Failure to do so will allow further water penetration which could encourage rot in adjacent timbers.

**View of roof space over upper accommodation**

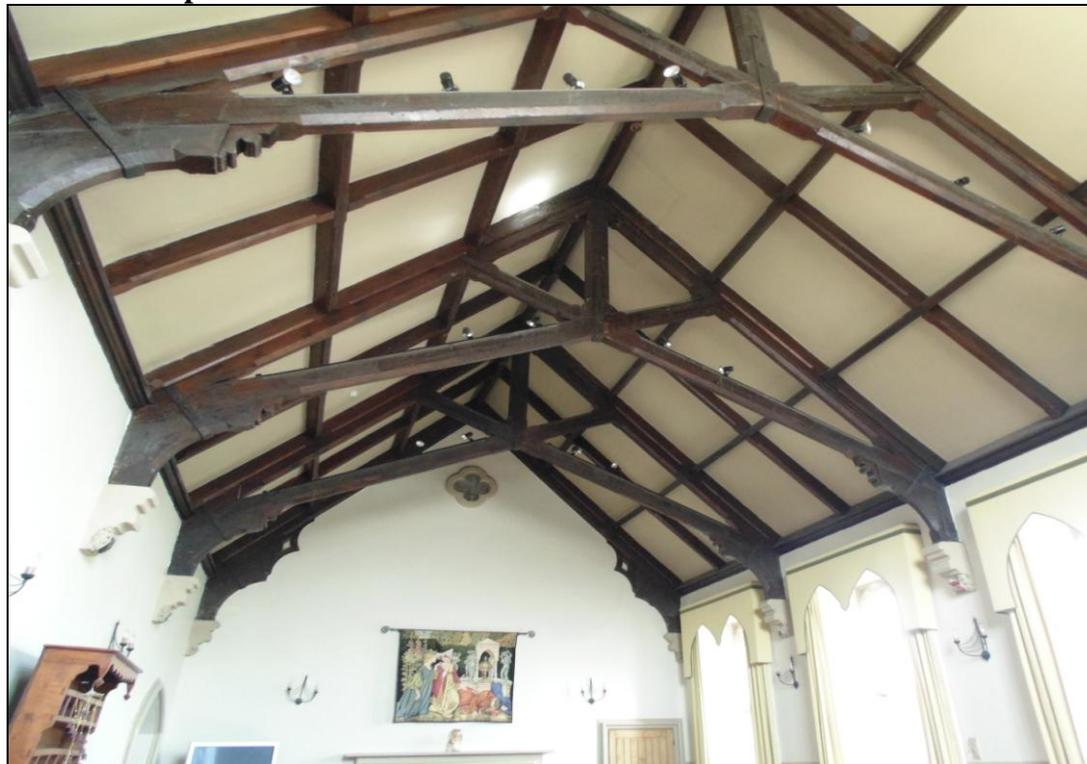
## **Attractive exposed timbers in Court Room**

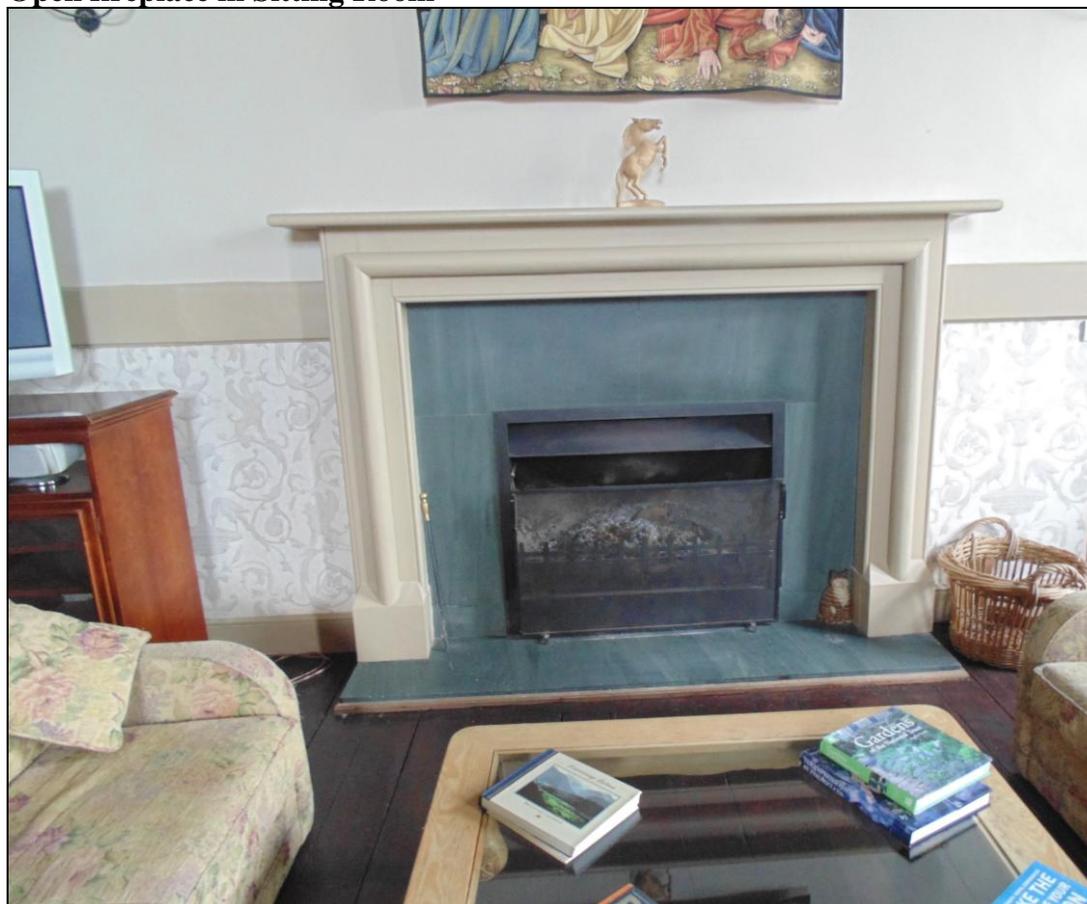
open fire in the main sitting room. This was not tested during the survey. If you are intending to use it as such we do recommend that the flues be swept and checked prior to use, particularly as in buildings of this age and type they are often decayed unless previously relined.

### **Open fireplace in Sitting Room**

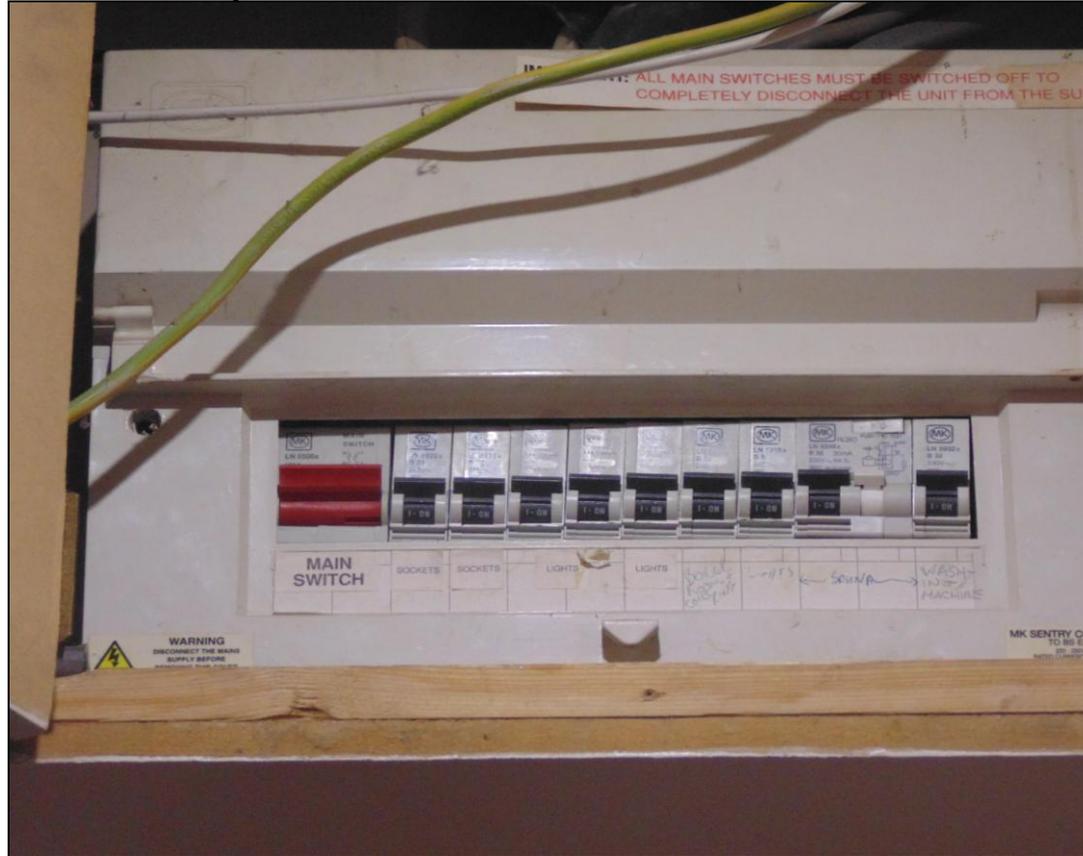
MCB's internally

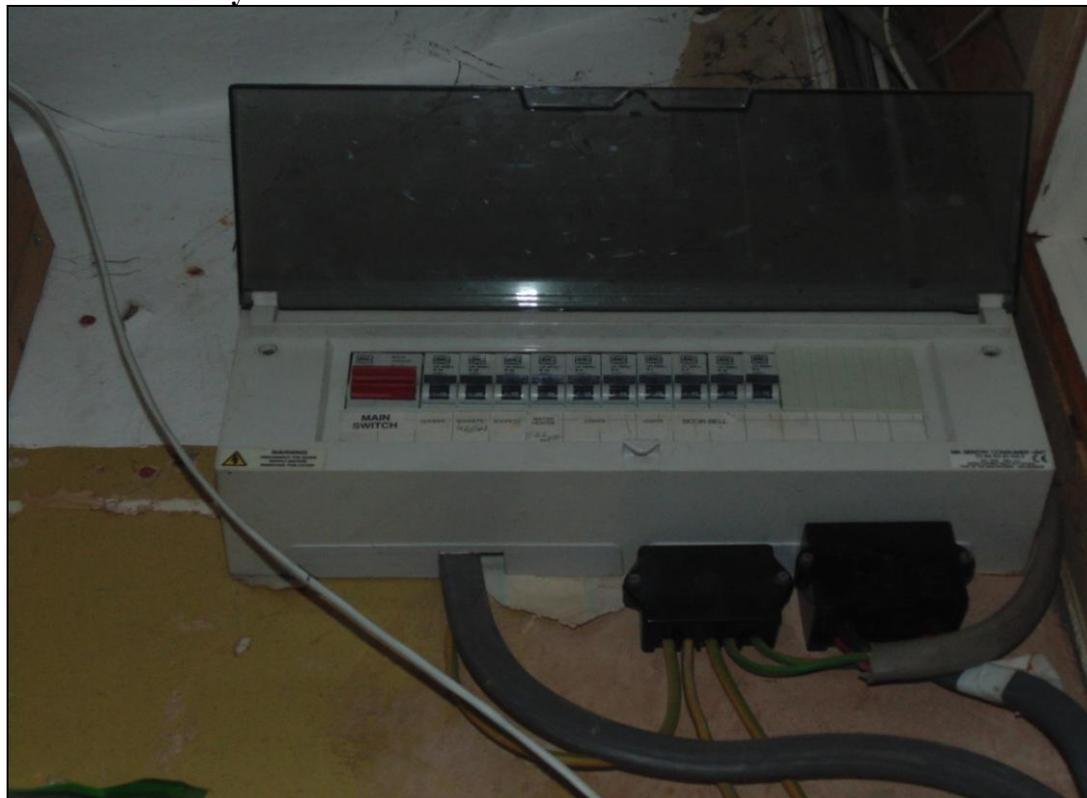
MCB's internally

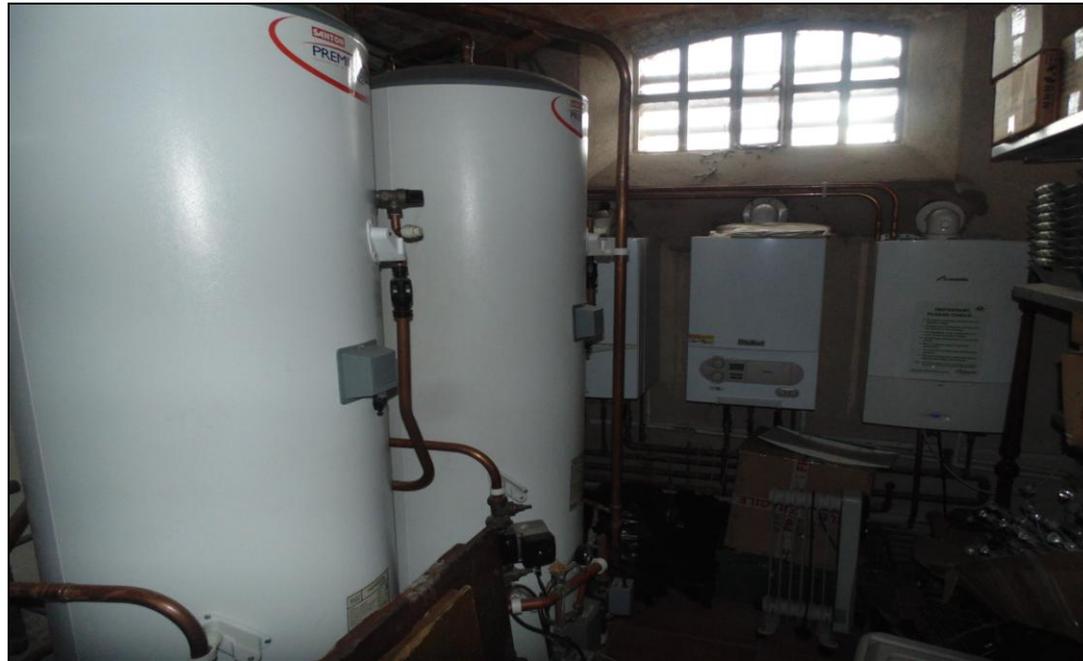
### **Modern boilers/water tanks**
